**C-W 11-A**

**Restoration of Cutting & Washington 11-A**

**Inspected 2-22-1923**

**Regenerative receiver of unusual mechanical construction.**

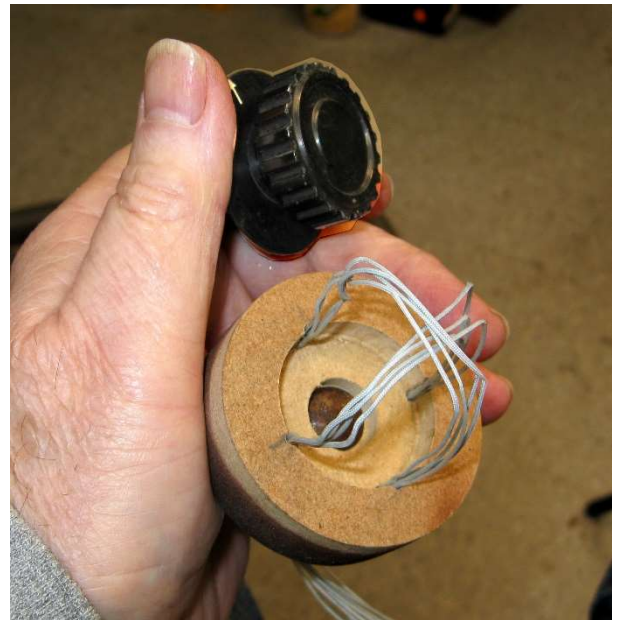
It was not at all clear how the dial bezels were attached... Were they glued, or did they have studs attached to the back? The hard rubber panel is attached to a massive 1/8" thick nickel-plated brass chassis plate only slightly smaller than the panel. I had no problem removing six of the seven knobs BUT, the last knob simply refused to slip off the steel rheostat shaft. Construction of the rheostat makes it impossible to free the shaft from the back side of the assembly. There was some sort of burr capturing the knob. The shaft could be immobilized, and the knob would spin freely after its set screw was removed. Try as I might, I could not twist and pull the knob off. I finally arrived at a unique extraction method with what I thought might be the least probability of breaking or scarring the Bakelite knob body.

On my lathe I turned a recess in a disc of MDF (Medium Density Fiberboard - shelving stock.) Four 2.5mm holes were drilled to align with four flutes in the knob. This MDF disc was then mounted to a carriage bolt. I gathered four strands

of Kevlar braided cord and tied the knob down in the well as tightly as possible. The carriage bolt was chucked in my cordless drill set on its higher speed range. The rheostat body was held to prevent shaft rotation. I spun the drill for about ten seconds at high speed while pulling on the knob, and it released! On inspection of the shaft, it was deceptively smooth as well as the brass insert in the knob. Apparently, the heat generated by fast rotation smoothed surfaces and wiped-away evidence of where the knob was sticking. The key thing for me was that the MDF and Kevlar cord were not abrasive enough to harm the Bakelite knob in any way.

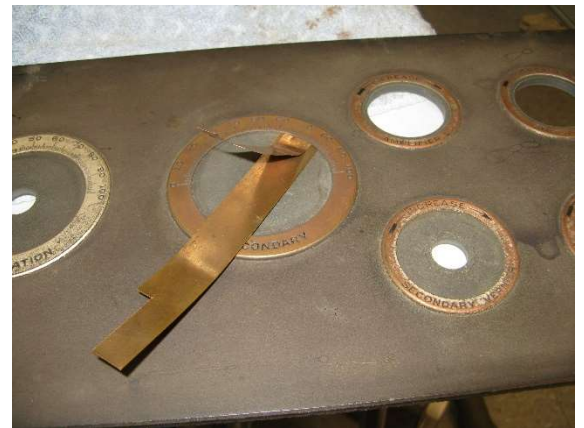
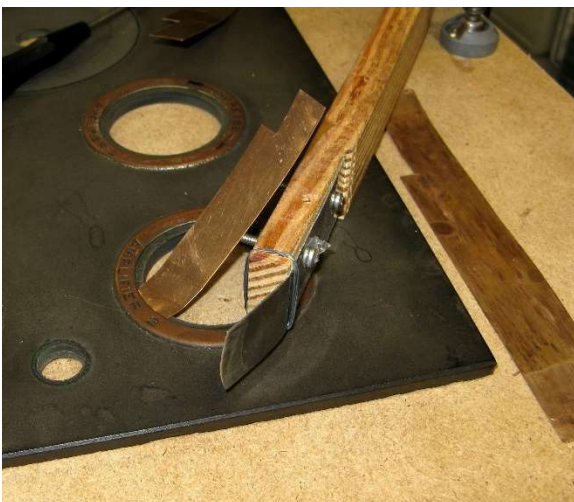
So now I was ready to separate the hard rubber panel from the steel chassis plate. I noted that the attachment was via #8 x 32 bottoming-tap holes in the less than ¼" thick hard rubber panel. My thought is that this must have been a very tedious task requiring high skill. And oh so, very, very easy to cross thread with the ¼" screws holding the two together. I was surprised to discover that there were no signs of attachment for the bezels! Were the bezels simply glued-on? I began to probe the inside flange of the bezel using a strip of 0.005" phosphor bronze shim stock. Only maybe half of the 7 bezels had any

gaps where this shim stock could be inserted a little way. I began a tedious process of trying to force the shim stock all around the bezel. The next step was to then try and insert another strip of shim stock under the first piece to create a 0.010" gap. I fabricated a strip of 0.016" stainless steel with a dull knife edge on one end and attached it to a wood handle. I could eventually force the tool blade into the 0.010"

gap. From there on, it became increasingly easy to wedge more strips and finally extricate the first bezel. Much to my surprise, it was not glue that was holding the bezels in place, but the outer ring of the bezel was a flange press-fit into a precision groove cut in the hard rubber panel! I had thought that the larger bezels would be the most difficult to extract, but that was not to be the case. I soon realized that the cut-outs in the rheostat bezels put the precision machined groove very close to my pressure points for wedging the bezel out of the panel. Any 90+ year old hard rubber is going to be far more brittle than the day of manufacture. The stakes were extremely high, so I spent several hours extracting the bezels and succeeded with zero damage.

For the bezels where I could not find enough of a gap to insert the first shim stock, I laid a single edge razor blade flat on the panel surface and used a wood stick to push the reinforced edge. Of course, the corners of the blade could have snapped, so I used a face shield and gripped the stick so that my thrust was extremely limited should the stick jump-off the blade. Fortunately, I did not have any accidents and the process produced enough gaps to insert the 0.005" shim stock.

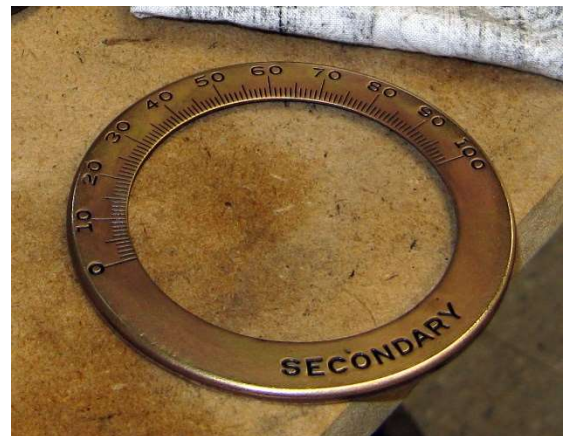
It was now time to try and remove the oxidation on one of the bezels using techniques that I have been using recently. I would have liked to have put these bezels in my ultrasonic cleaner, but I did not want to remove the black and red paint filling the markings embossed in the brass. I found that the brass did not return to the bright yellow luster I have experienced on my other cleaning tasks using peroxide and sodium bisulfite acid... Yes, it looked like cleaned brass, but it still appeared uneven in coloration and I feared that it would interfere with the electroless silver plate solution. I was correct and unpleasantly surprised to see virtually no affinity for the plating solution on my cleaned brass even though the solution is described as working on brass surfaces. I repeated the cleaning steps several times and still no deposition of the silver. I was not at all prepared for that outcome.

I am not equipped for electroplating silver so I decided to see if I could deposit electroless tin on my parts. I had recently had success in tin plating some old

copper bus wire using this solution. The same bezel was again cleaned and placed in the tin solution and immediately began to plate-out onto the brass fairly well. The tin presents almost the same color and luster as old silver, so after rinsing and light buffing, I sprayed a coat of clear acrylic lacquer on the bezels and called the job done.

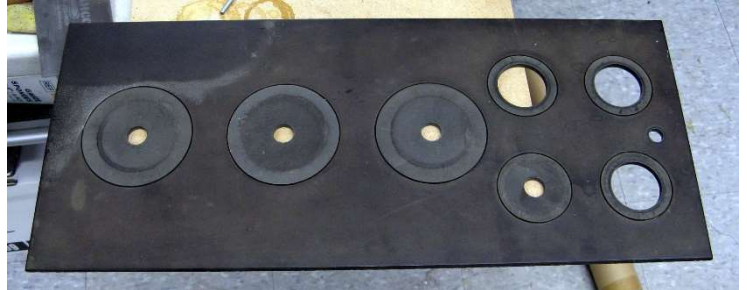
Now that the hard rubber panel was free of all parts, I could employ the cleaning methods learned through experimentation in the past two years.

First of all, under no circumstances should you apply any water-based cleaners to old hard rubber. If there is any grime to remove, use a *waterless* hand cleaner like *Goop* or *Go-Jo*. Wipe-down with mineral spirits. If the surface is rough, sand with 220 grit paper lubricated with mineral spirits. To achieve a satin finish, continue rubbing with #0000 steel wool lubricated with spirits and using long linear strokes.

Once you have the surface finish to your liking, wipe-down the entire panel with fresh spirits and rub as dry as possible with a clean rag. Take the time to use Q-Tips to dry the insides of holes in the panel and do the same along any edges of the panel. Otherwise the spirits will wick-out in following steps.

There is no way to determine how deep the oxidation may be on a hard rubber panel, you are not likely to get back to a uniform original coloration. You may decide to simply stop at this point, give the panel a coat of wax and move-on to other things. But on some projects, you may want to improve the coloration. I have found that you can apply an aniline wood dye in alcohol solution, in this case black, to the panel. I use “Mohawk's Ultra® Penetrating NGR Stain”. This can give you an even color, BUT there is a critical illumination angle to viewing the panel where you will see a very pronounced magenta hue. I have found that this hue can be eliminated by polishing the panel with colored wax specifically made for rejuvenating black painted cars. “Turtle Wax Color Magic Car Polish - Jet Black” worked well on this project. I then very carefully pushed a shaved toothpick through the machined grooves to make sure there was no trace of debris.

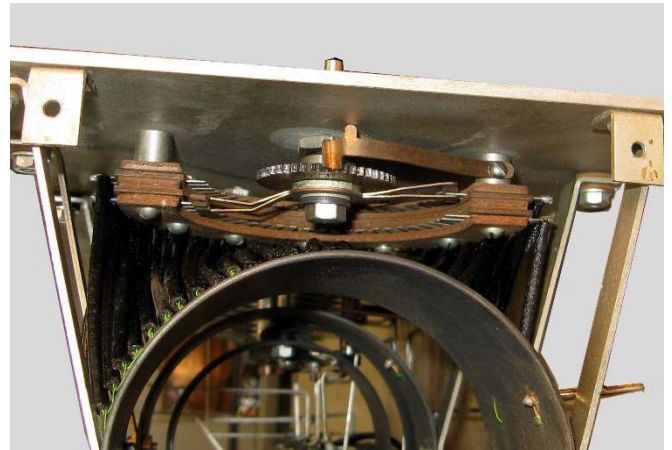
The primary tuned circuit has an amazing inductance with a tap at every turn for a total of 50 taps! The 50-tap switch looks to be virtually the same approach as used in the Strowger telephone relays of the day. The regeneration is controlled by a variometer. A parallel tuning capacitor is across the secondary with an outboard single vane rotor for vernier capacity adjustment. When regeneration is advanced, the tuning becomes so very sharp that the Vernier is essential.

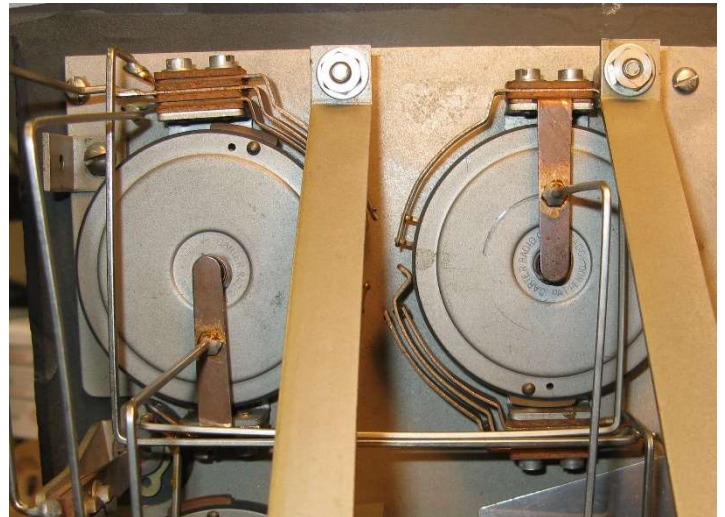
Note that there is only one headphone/horn speaker jack on the radio. The construction of the Carter brand audio amplifier filament rheostats is a marvel of out-of-the-box thinking in the way that they are configured with automatic bypass switching when the rheostat is turned off. This allows the plate connection of the detector, first audio or second audio to be routed to the single output jack.

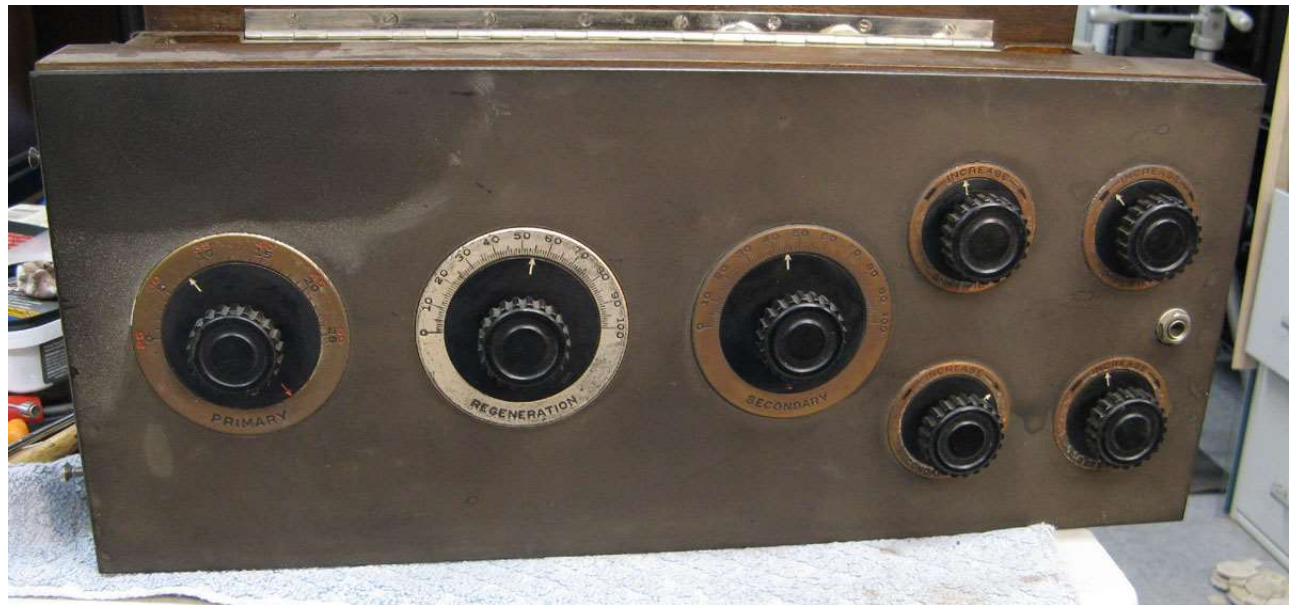
**This receiver was acquired in the 1990s and attempts to salvage the appearance of the hard rubber panel were a general failure. I also had no way of restoring the plating of the brass bezels. In January 2020 I thought that I had acquired enough new skills and information to revisit making this receiver suitable for exhibition.**
