# Kolster 3D Printed Parts

To date, I have identified only two radio restoration projects that have come to my shop that could be assisted using 3D printed parts. The first is a replacement loudspeaker grill for the Philco 47-204 and internal parts for the 1926 Kolster Model 6D TRF Receiver. This article describes parts for the Kolster.

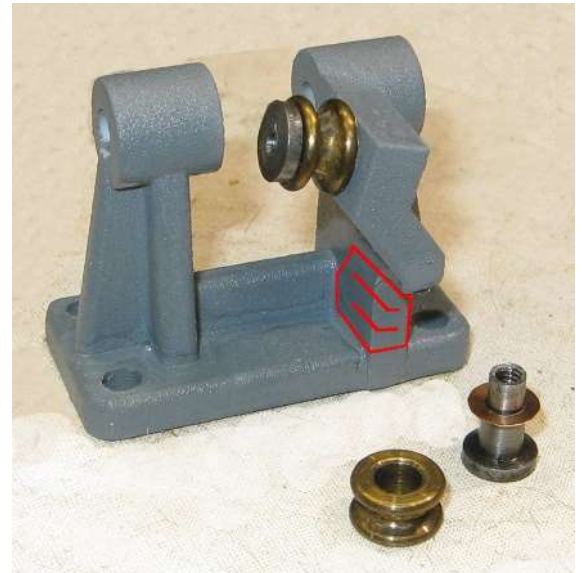
*Figure 3 - Extra fill added for rigidity.*

In the case of the dial drum drive bracket, it was necessary to build a thick portion up from the base to support a robust angled feature for two idler wheels. It was easy to cut away the excess material to better match the appearance of the original part. Here again reamers were used to provide accurate holes.

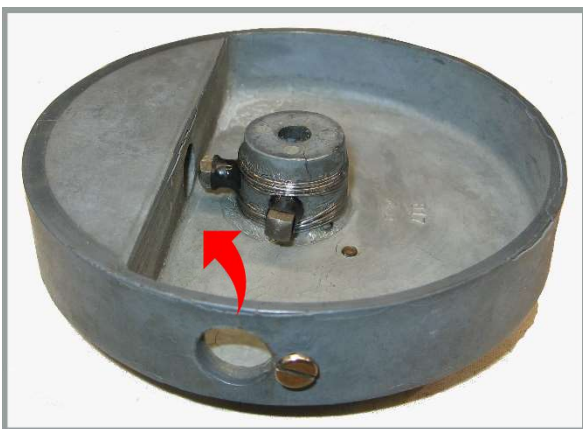
*Figure 4 - Drum incorporates counterbalance weight; would have to be a separate lead part mounted inside a 3D printed plastic version.*

In this 6D receiver, the 4" diameter tuning dial drum (Fig. 4) is still in good enough condition to work. Cracks around two set screws attaching the drum to the 1/4" diameter steel shaft of the tuning condenser rotors were reinforced by wrapping the hub area with #22 gauge stainless steel wire and then saturating with epoxy resin. This part is relatively large, and I suspect that the cost of getting it printed would be in the \$75 to \$100 range. I think there is a fair chance

that this repaired part will remain serviceable because it is likely to stay in an area of relatively low humidity and stable temperature. I did, however, take the opportunity to measure the part and generate a 3D model.

Again, while the original dial drum is a single casting, I determined that a relatively low-cost Nylon part would need to be printed in two parts. It would also require a simple aluminum bushing with two tapped holes to securely index the drum on the condenser rotor shaft. For long term stability of the part, the printed part needs radial ribs with fillets to support the dial scale not seen in the original part. In addition, there is a large mass of pot metal in the part that serves as a counter balance for the brass condenser rotor vanes. A properly operating 3D printed part will need to have a separate lead counter weight attached. The good news is that these alterations to the original part dimensions cannot be seen when the chassis is in the cabinet.

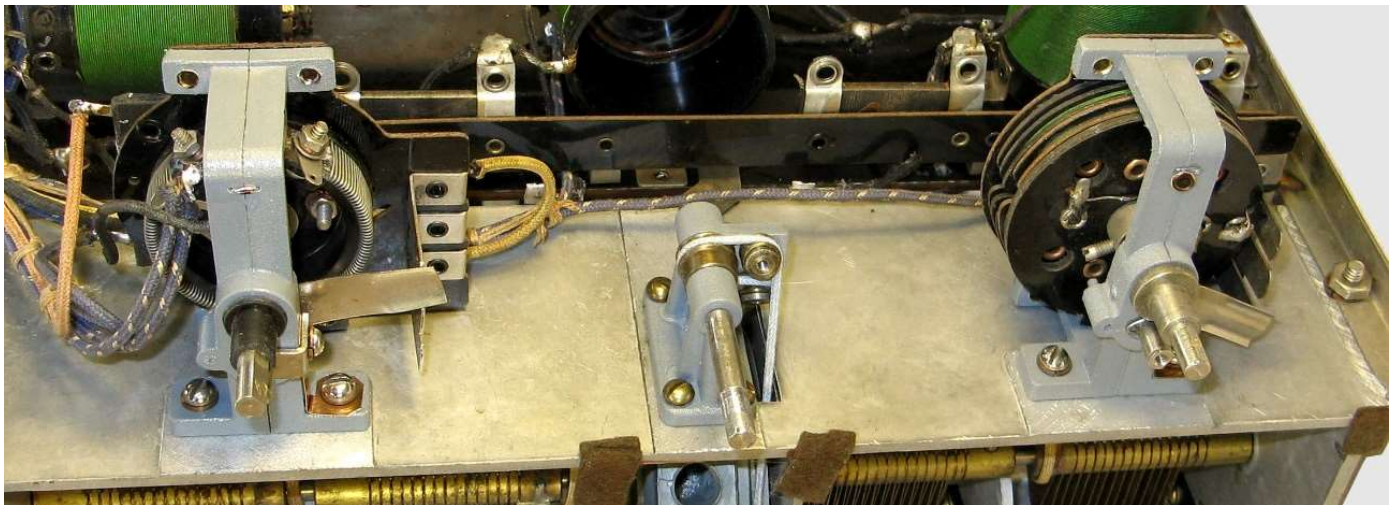
Figure 5 - 3D Printed Parts installed. Left, rheostat bracket - Center, Drum drive, Right, Variometer bracket.

This type of Nylon can easily be painted to look like the original pot metal casting. The rheostat/variocoupler bracket is used to make an electrical contact from a switch arm to the receiver chassis. It was an easy task to cut a strip of phosphor bronze shim stock and glue it along the side of the Nylon bracket to complete the circuit.
