Mercury Super Ten (1926)

The H. M. Kipp Co. Ltd. – Toronto – Canada

Narrative of bringing this receiver to its current state of repair.

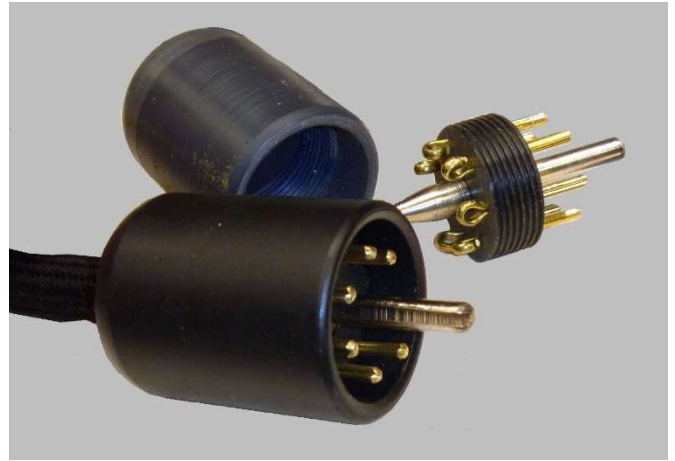
too uses the same Jones Plug for battery connections. I determined that an attempt at this receiver restoration was futile unless I could solve the Jones Plug problem. I was eventually able to figure a way to make seven convincing plug replicas with my available home shop tools and skills.

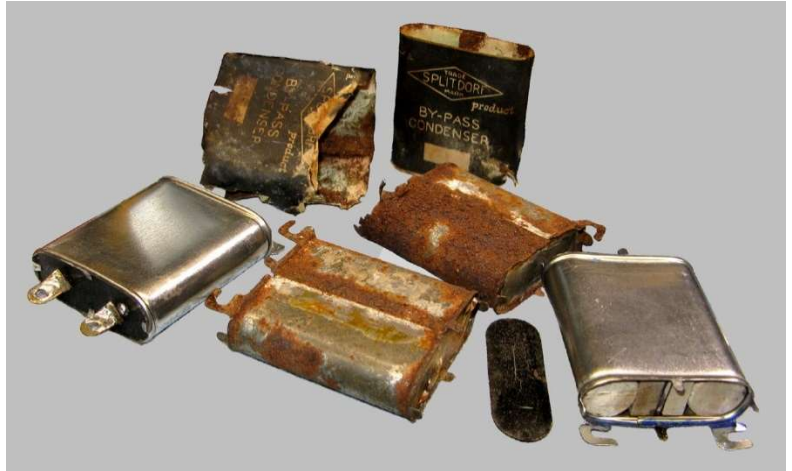
I had never looked closely at the dirty chassis just presuming there were not any serious 'gotchas'. I was **WRONG!** Buried under the Oscillator and Tuner variable condensers (capacitors) are two *Splitdorf* brand B+ bypass condensers. Apparently, water had somehow condensed under these

parts big time over the years and one sheet metal case was now destroyed and the other case was not much better. Finding good exact replacements are unlikely so I set to work recreating these tin cans and their destroyed labels. The cans were originally die-stamped and had tiny rolled flanges to capture Micarta end caps. (Micarta is a trade name for sheet goods built of layers of linen saturated with phenolic resin much as fiberglass printed circuit board G10 material is made now.) I could salvage the old end caps, but it turns out that this tin can with its rolled ends and tiny tabs to capture the end caps was, for me, a very tedious and less than perfect task with the tools at hand.

Both capacitor internals were shorted and were discarded and replaced with modern film capacitors inside my reproduction cans. This was done because no space could be found to hide modern parts elsewhere. With my experience in

recreating the graphics for radio batteries, I had no difficulty in scanning the paper label for the units and recreating an exact graphic for printing.

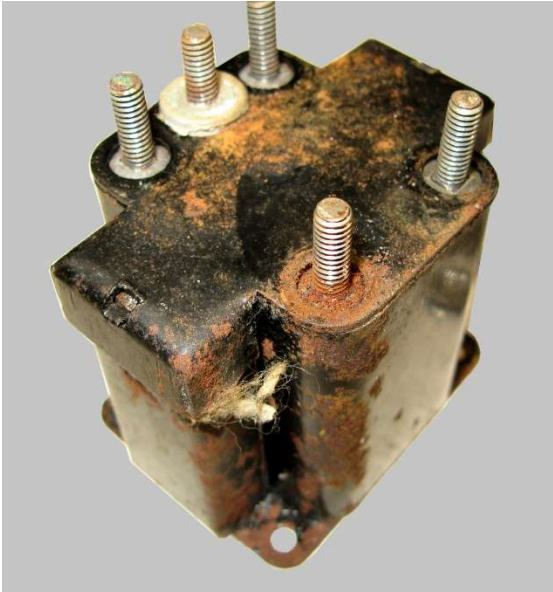
Figure 1- Rusted case requiring repaint but actual windings are still OK.

This radio has audio transformers that are certainly made by Thordarson even though there is no such attribution. The Thoardarson transformers I have encountered are most often OK and the ones that do test bad have a fair number of them that register open circuit but can be repaired. With care the case can be opened, and I have found that the #8 threaded

studs going through fiber insulators can rust heavily and effectively disconnect the

solder lug where the winding leading-out strap is soldered. That was true on two of the three audio transformers in this radio. After removing the rust with a clockmakers glass fiber scratch brush and reassembly they now test fine.

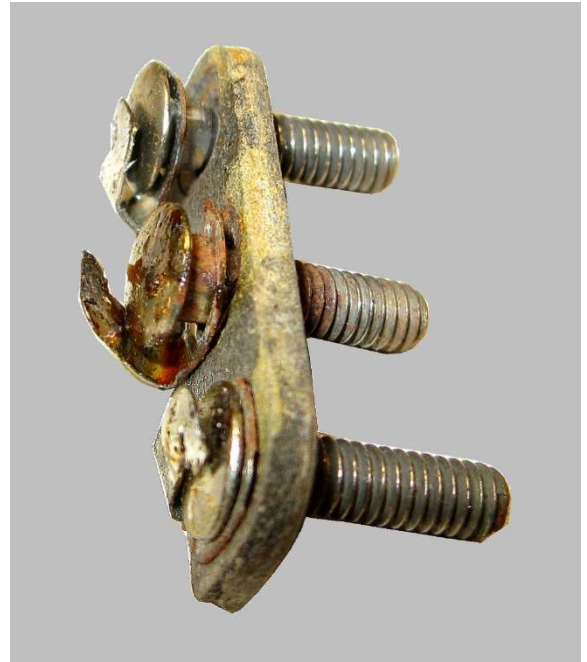
Figure 2 - Solder lug disconnected by rusting of #8 stud.

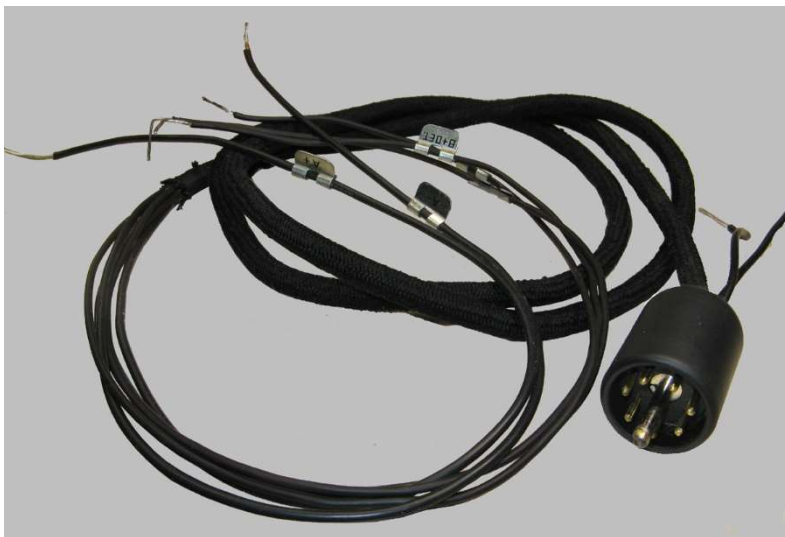
I turned to making a replica battery cable using the same braiding fixture I designed to make two other replica battery cables. A detailed article on this braiding fixture appeared in the Summer 2019 issue of the *BVWS Bulletin* (UK). The heavily deteriorated cable that came with my radio had black rubber covered wires with a black over-braid jacket for the bundle of wires. I was having trouble finding a black stranded wire that looked anywhere near that in my useless cable. The answer came when I discovered that there is silicone rubber covered high flexibility wire rated for 200 C. It carries a designator of UL-3135. And I was happy to find that you can buy 30-meter lengths of 18 and 16 AWG in colors including Black on eBay for about \$38 post-paid. More than enough to make my replica cable.

I have seen three different Jones Plug battery cable assemblies with different wire inside the braided outer jacket. One has the plain black rubber covered wire, another has thinner black rubber covered wire with an individual black braid over the wire and the third cable has the same thinner black rubber covered wire, but the wires have

different color braiding. To make things even more confusing, the wires are tagged differently. One with printed cloth tags, another with Celluloid tags, another with individual, postage stamp sized string tags and if that were not enough, one of the cables even has ends of the plain rubber covered wires covered for about 3" with a different colored varnish! The replica cable I made is tagged with vintage crimp-on metal tags at least until I obtain further documentation on cables appearing on 1926 model Mercury receivers.
