Found in the collection of the Lauren Peckham estate, a maybe unique type of broadcast radio receiver.

Electradyne Peerless Two Tube Super Reflex Receiver

**Peerless Radio Corporation
2527 Park Avenue, Chicago, Ill.
Circa 1926**

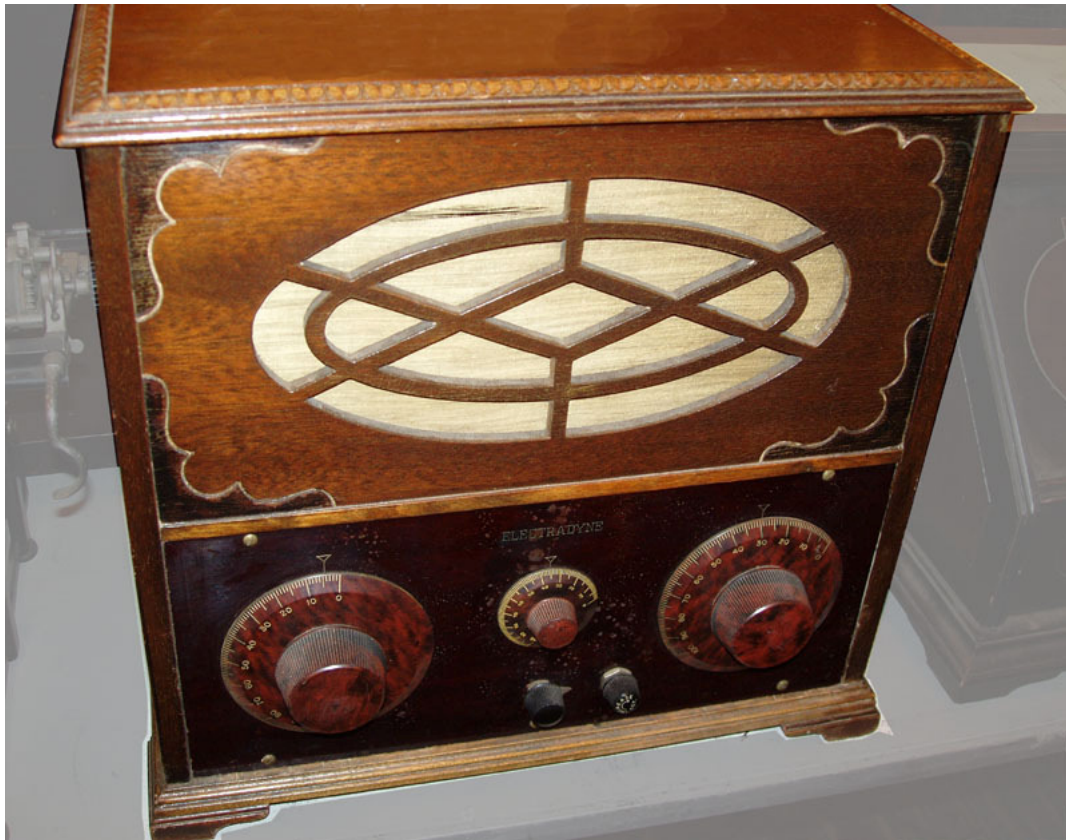
Unique in the power source for this radio.

The factory provided capability of using a 6 Volt storage battery OR 110 VAC from the house lighting circuits to light the filaments of the two Type 01-A vacuum tubes. (More later.)

This receiver is certainly to be regarded as a 'local' receiver of minimum tube count to drive a built-in loudspeaker. The similarities to the Harkness Reflex designs are obvious.

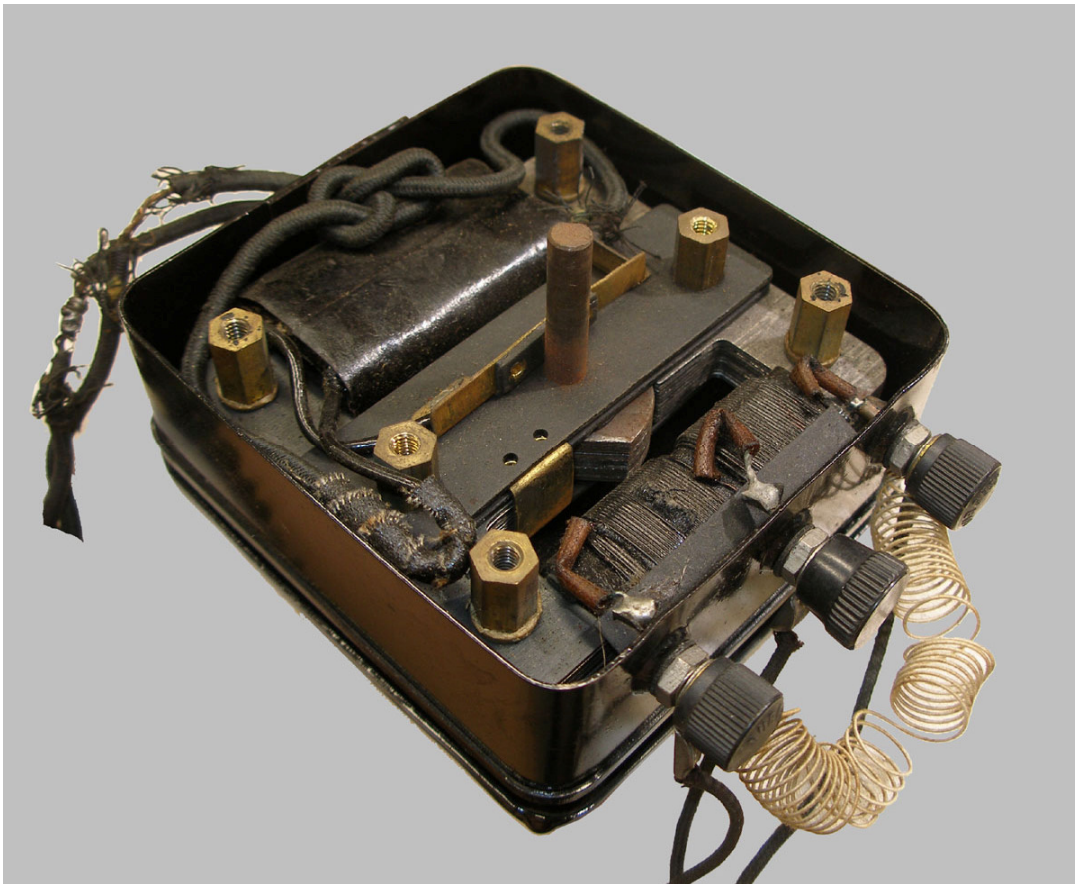
As mentioned above, the radio comes with the ability to light the filaments of the ¼ Amp. Type 01-A tubes from 110 VAC mains power. This is done by the use of a RADIO-POWR #4 adjustable transformer made by the Electrical Division of the Eagle Carburetor Co., Cleveland, Ohio. Trade mark #188,897 in use as of October 1, 1923. Patents pending is indicated but I have not been able to find any patents granted or advertisements in radio magazines of the day.

There are three legs to the transformer. One outside leg has the 110 VAC rated primary. The other outside leg has a low voltage center tapped secondary. The center leg has no winding. In the center of that leg there is a rotatable stack of laminations. By turning the stack, the degree of magnetic flux through the leg can be made to change. This in effect shunts the primary induced flux away from the secondary winding and thus the output voltage drops. With the two tubes and a separate coil of resistance wire

connected as a load to the transformer output, the output can be varied over a range of about 2 to 5.5 Volts. This same type of transformer construction was in use for electric arc welding in the early 1920s but did not come into general use until the 1930s. Did the RADIO-POWR idea come from the AC welder transformer technology? I don't know.

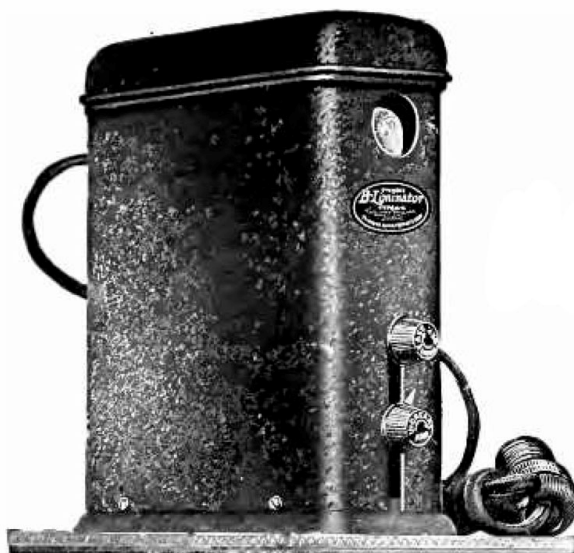
Patented May 15, 1923

AC operation. This is accomplished through the use of a packaged module made by Timmons Radio Products, Philadelphia, PA. Timmons was one of the first 'B' Eliminator manufacturers. According to discussions on Antique Radio Forum, there may be a number of manufacturers claiming 'first-to-market' in 1924. The Timmons advertising states "Patented May 15, 1923". Alan Douglas identified this as a Lowell & Dunmore patent # 1,455,141 which showed a triode with grid and plate tied together as a rectifier. Reference: Lowell & Dunmore in the *AWA Review* Vol.3

I have seen no documents that describe Timmons as offering parts to be built into radio power supplies... But I cannot imagine that someone would have bought a complete Timmons supply and then stripped it down. The tube socket does indeed have the plate and

grid shorted together and the filament operates at a nominal 5 VAC with a filament rheostat in series. So I must presume that the 01-A is used as a half-wave rectifier and is the desired tube for this installation.

After making resistance and current checks, I did power-up this eliminator and found that it could easily deliver 15 or so milliamperes which is more than enough to power this radio. The quiescent current of the supply was very low indicating little leakage. That is good because the entire module is potted in what appears to be tree rosin rather than the more-to-be-expected asphalt compound.

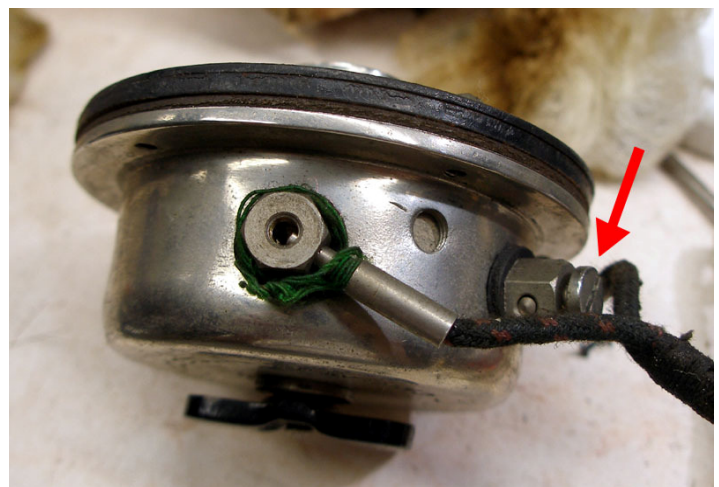
The horn driver is made by Burns. There was nothing wrong with the function. The only problem is that one of the terminal screws had been lost long ago and a little bit of extra wire was being used to keep the speaker cord tip in place. The screws are 5-40 old style pan head screws as used in telegraph and telephone instrument manufacture. I have yet to find a correct one in my junk boxes or on the Web. Do you have one?
