Oriole Model 100 - W-K Electric Co. Kenosha, Wisconsin. Circa: Spring of 1927

Oriole Model 100 Description

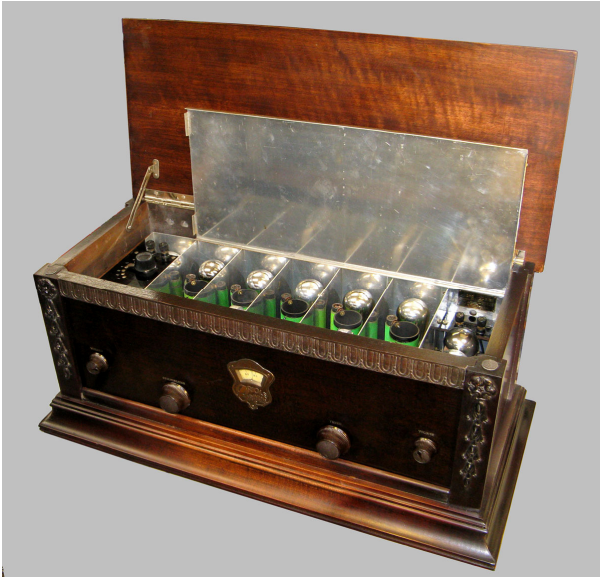
This, apparently, final design recognizes the industry trend to sell the notion of 'single dial tuning'. Sure enough all six tuning capacitors are ganged via large cut brass gears with a clever zero-backlash spring loading feature.

With the front removed I could inspect the tuning linkage between the six tuned circuits. There are six brass gears with an anti-backlash feature that was not unexpected and seems to work well. What I did discover, that I cannot recall having ever seen before, is a method of vernier capacitor adjustment on the first tuned stage.

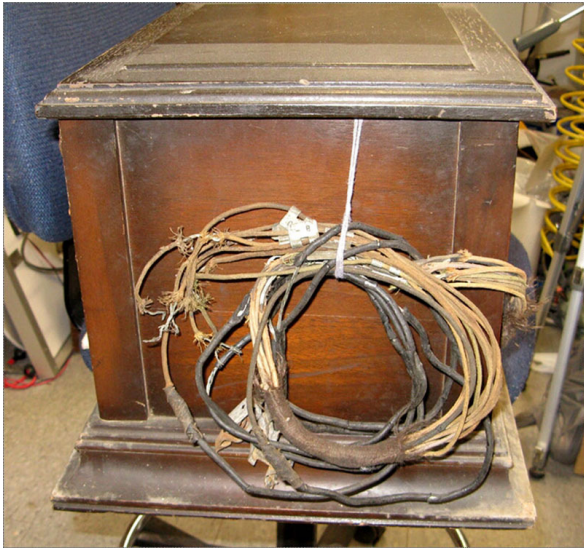
In this Oriole radio the 'deal killer' is the 9 conductor battery cable hard wired to a tag board under the chassis. The cable is severely deteriorated and cannot be salvaged. I made a replacement cable using techniques developed during the restoration of my second Swedish Radiola M55 of 1927 vintage.

The battery cable is a little shorter than I would have expected. But there is evidence that the cable was never longer because each wire has a metal ID tag attached just about where you would expect it to be. There are 7 – 20 gauge wires and 2 – 16 gauge wires to service the filaments of the 8 type 01-A tubes.

Here I used 20 gauge cloth covered wire obtained from *Radio Daze*. This is the closest wire I've seen to replicate the original rubber insulated wire with color coded cotton over-braid. Unfortunately this reproduction wire uses common PVC insulation which makes the wire much less flexible. I have found that it is possible to get black silicone rubber covered wire in similar gauges. It is rated for 200 C environments while PVC type wires are rated no more than 105 C. It is no doubt more expensive but I would gladly pay more to get reproduction wire as flexible as was available 90 years ago.

I have an old spool of 16 gauge stranded hookup wire that must date from the 1950s that has a green dyed braided covering. It is still in fine, flexible shape. I found that I could bleach the color from the wire braid and then use RIT brand dye to make Red and Black 'A' supply wires for my new cable.
