Rees-Mace

4 Valve Transportable -- London, UK -- Circa 1929/30 With decal saying: Rees Radio - Paris

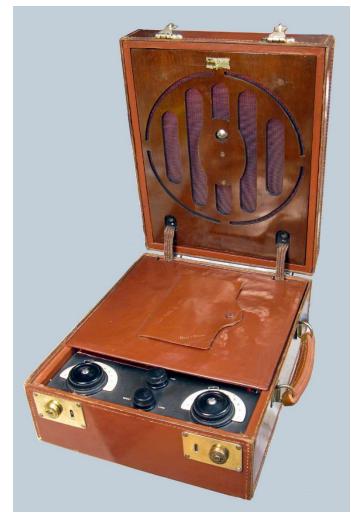
The receiver on exhibit here features a screen grid RF amplifier valve that was not in general use until 1929. There is a reaction (regenerative) detector and two stages of transformer coupled audio amplification.

The frame aerial surrounds the moving vane loudspeaker and tunes both the long wave and medium wave European broadcast bands. This receiver is unusually compact for a loudspeaker portable of the day mainly because it uses a tiny 2 Volt accumulator (storage battery) instead of the usual multiple dry cells for filament operation. (Brand name unknown.) The tuning log advises that the accumulator be charged every 10 hours. It uses a 90 volt 'B' battery and 9 Volt 'C' bias battery, both made under the Leclanché brand name.

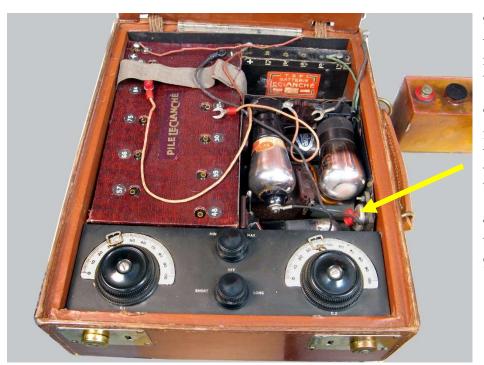
Two valves are mounted vertical in this picture, the other two valves are mounted at right angles underneath the two visible valves.

The yellow arrow points to a small flashlight bulb painted with semitransparent red paint. It is in series with the negative lead of the 90 Volt battery and serves as a fuse.

The two-Volt accumulator fits between the receiver chassis and the 9 Volt 'C' bias battery.

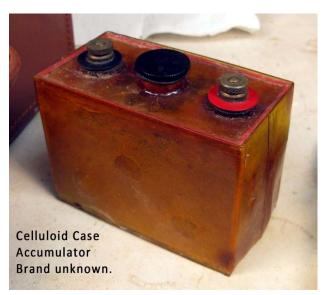
The station log booklet states that the little two-volt Celluloid cased lead/acid battery should be recharged every 10 days.

Apparently, it used a gelled sulfuric acid electrolyte.
