Vintage radio item with little-known facts or lore.

Category: 1920s American made broadcast receiver.

Sumter Radio Manufacturing Co.

Presented by : Robert Lozier – KD4HSH

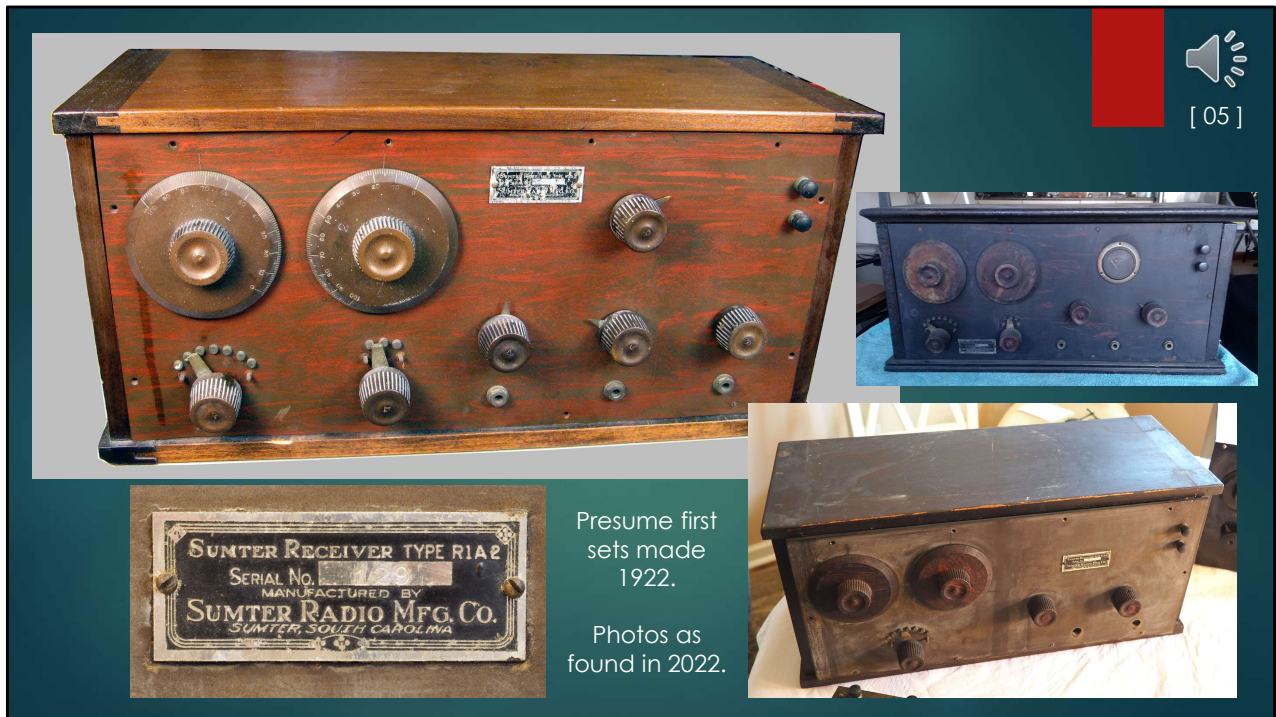
[05]

Presume first sets made 1922.
Photos as found in 2022.

Apparently, by 1922 part of the main factory building was being rented or leased to a business named the Sumter Radio Manufacturing, Co. It may have been the same location of the Sumter Machinery Co. and a sub-contractor for their parts. At this point there are four of these sets known to be in existence and there is one in the South Carolina state museum. None of the versions are identical. Serial number tags suggest that there may have been about 500 sets built over maybe a two-year period. The three I know about are in poor to awful condition.

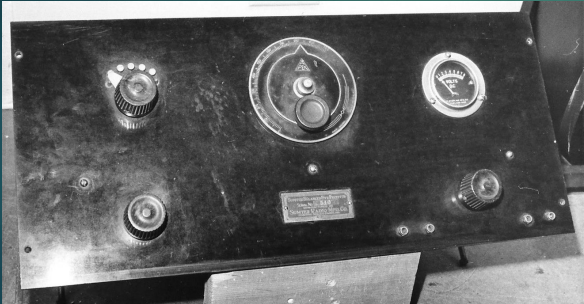
There is supposed to be another Sumter radio, but the owner has not permitted any pictures to be made or provide a description. They presume it is very valuable and is expecting an outrageous price. These photos, presumably made the 1960s, show a "Sumter Balanced Five Receiver" Serial # 510 It is not known if it still survives. There are no clues as to whether this could be the mystery fifth set.

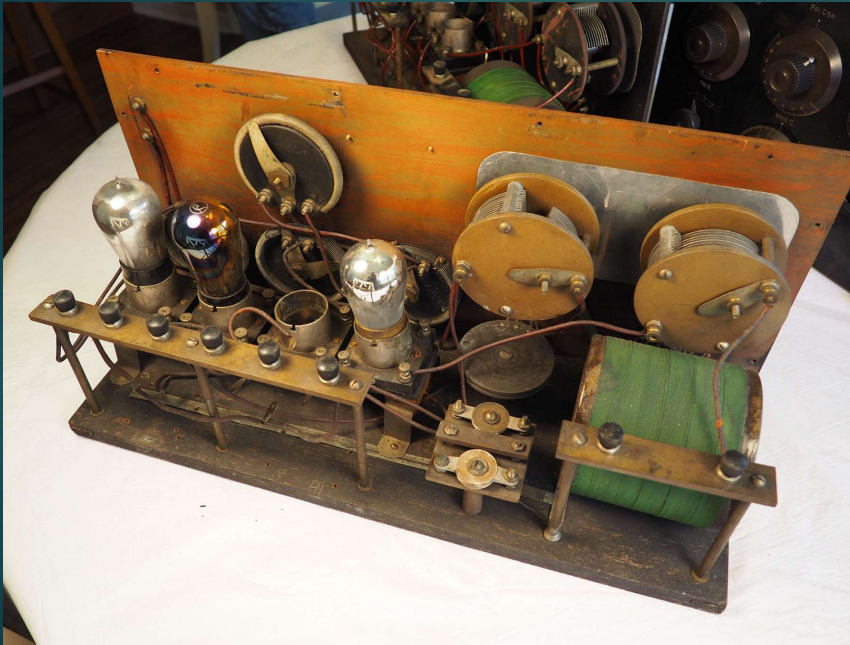
All appear to be sets with one stage of TRF, a non regenerative detector and two stages of audio. All front panels are hard rubber in either gloss black or faux wood grain like this pictured version. The tuning capacitor end plates and terminal strips are also hard rubber.

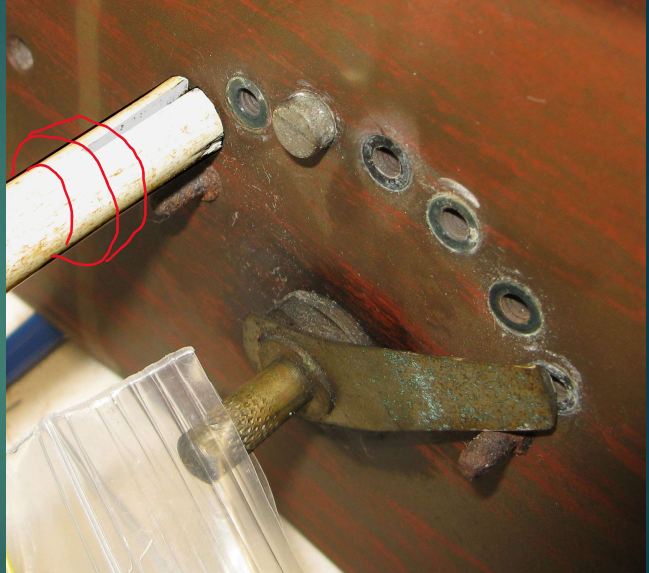
The hard rubber panel is warped, rough and encrusted around hardware; everything must be removed.

Corrosion and soldering heat have threaded contacts frozen in place. How to grasp for removal? A make-shift locking collet to grasp and unscrew contacts.

A length of 3/8" diameter fiberglass rod. Drill a hole in the center of the rod end just a little bit less in diameter than the diameter of the frozen contact. Use a hacksaw to make two cross cuts across the end to form four fingers. The rod fingers are forced over the contact. (I forgot to take a picture here.) The fingers do not grasp the contact tight enough. I used a very thick metal washer the i.d. of the rod and forced it down as far as possible onto the fingers. It was now possible to unscrew the contact without damaging the contact.

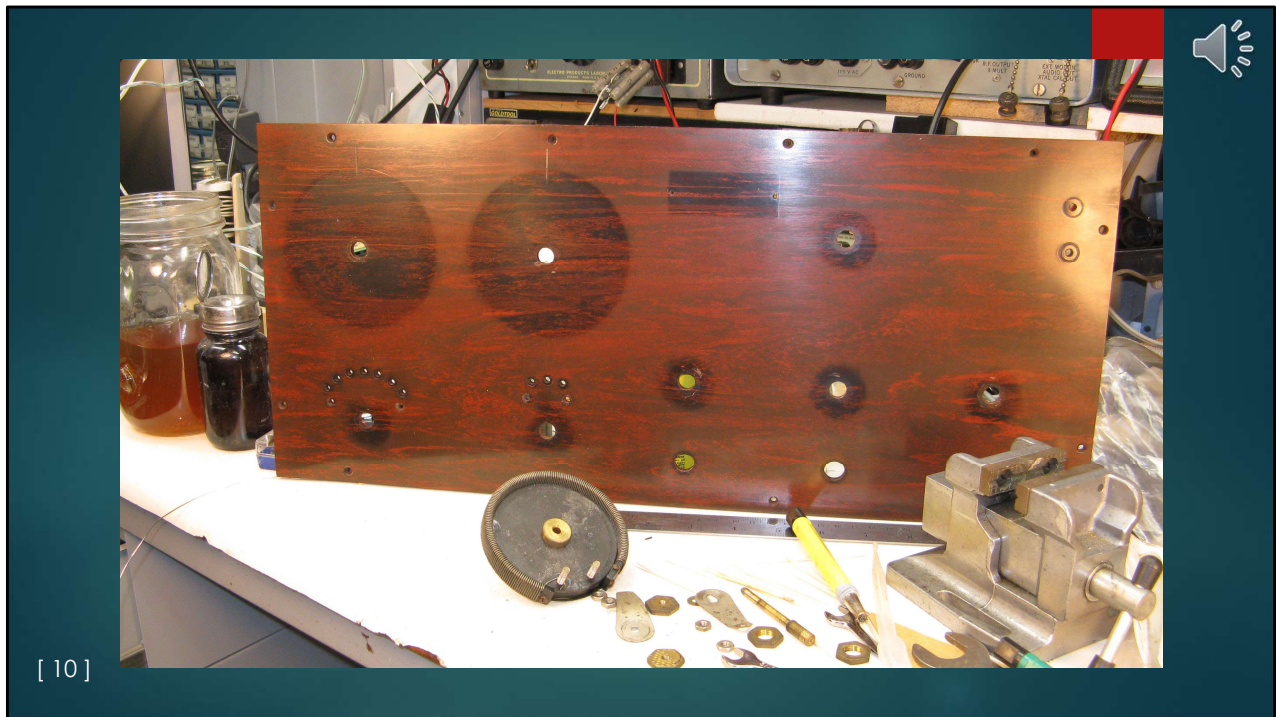
As said, All these hard rubber front panels are warped. The safest way to flatten old hard rubber is gentle, dry heat. These panels are unpredictable in how much heat they can tolerate, and the heat must be applied very evenly. My kitchen oven temperature swings wildly as it cycles... I've measured 50-degree F temp swings, much too risky for these irreplicable items. This is the third time I have used a makeshift solar oven to heat the hard rubber panel enough to soften so it can be clamped between two sheets of MDF shelving for cooling. It is easy to make and use if you have a sturdy camera tripod. I have a piece of scrap plywood maybe 14 inches square. In the center I drilled a hole to take a 1/4x20 T-Nut.... They are made for 3/4" thick lumber, so I had to add a little square of 1/4" plywood to make sure the threaded barrel would not extend beyond the surface.... As you can see, I attached this panel to the bottom of a cardboard box using zip ties. This screws onto the standard camera tripod mount. In the bottom of the box, I placed a scrap sheet of Styrofoam insulation to limit heat loss. The idea is to prop the warped panel up against the Styrofoam panel in the bottom of the box and cover the box with a thin sheet of clear polyethylene film. I use a disposable poly drop cloth. I happen to have a multimeter with a switch setting to take dirt cheap K-Type thermocouples. So, I place the thermocouple tip between the panel and the Styrofoam sheet. If the air temperature is approaching 60 degrees F and sun shining bright, the temperature on the back side

of the rubber panel should rise to above 140 F in about 15 minutes. Make sure that the box is oriented directly at the sun. After a 20-minute soak, put on a pair of cotton gloves and quickly remove the panel and immediately clamp between two pieces of MDF shelving. Double check that you have adjusted your clamps so that the boards are perfectly parallel meaning that all parts of your rubber panel are receiving pressure. Wait more than 30 minutes before removing the clamps so that the panel can return to ambient temperature when out of the sun.

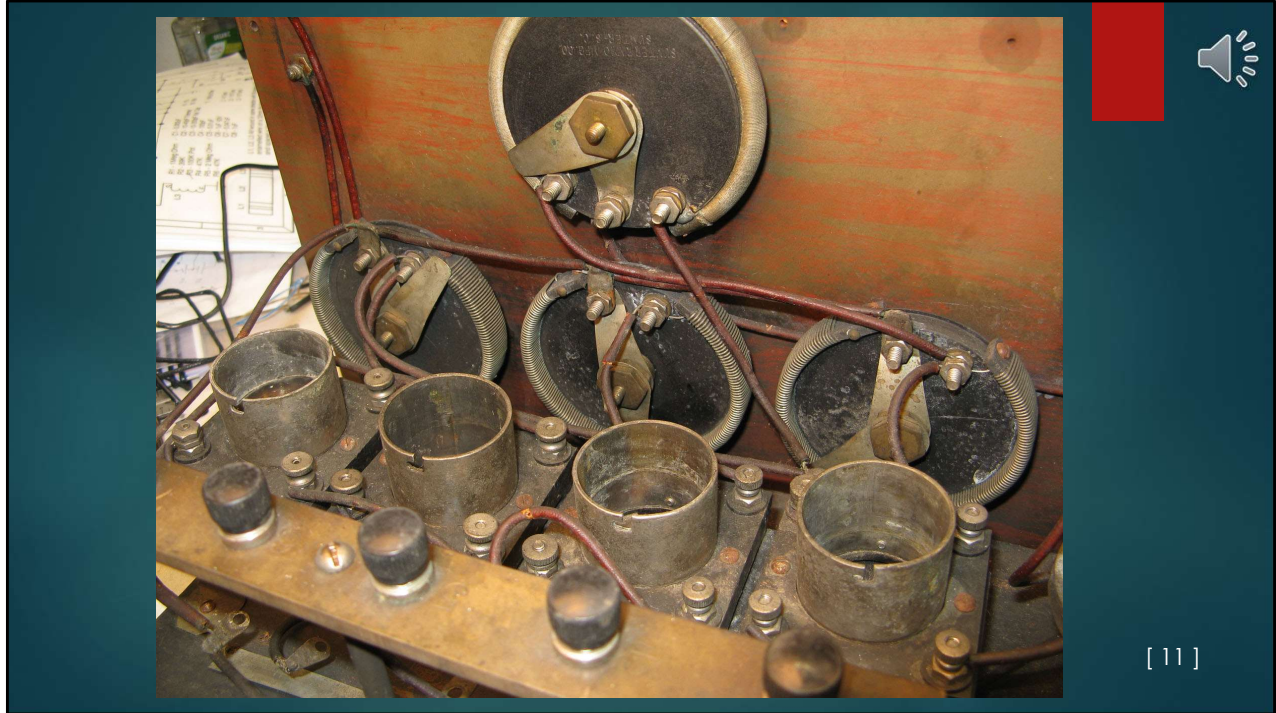
So here is the hard rubber panel after flattening using the solar oven. I know of no way to determine how deep the rubber oxidation penetrates after a hundred years. It took a LOT of elbow grease to brighten this panel to this point. I simply lost nerve to try and go deeper by sanding even though I know the color striations go through the entire panel. I used Go-Jo and steel wool. You wipe away the Go-Jo with mineral spirits before judging your progress. Never, ever use any cleaner containing water on old hard rubber, even worse if it is caustic in nature like many automotive degreasers.. I finished using a car wax containing a mild abrasive (often described as deep cleaning)

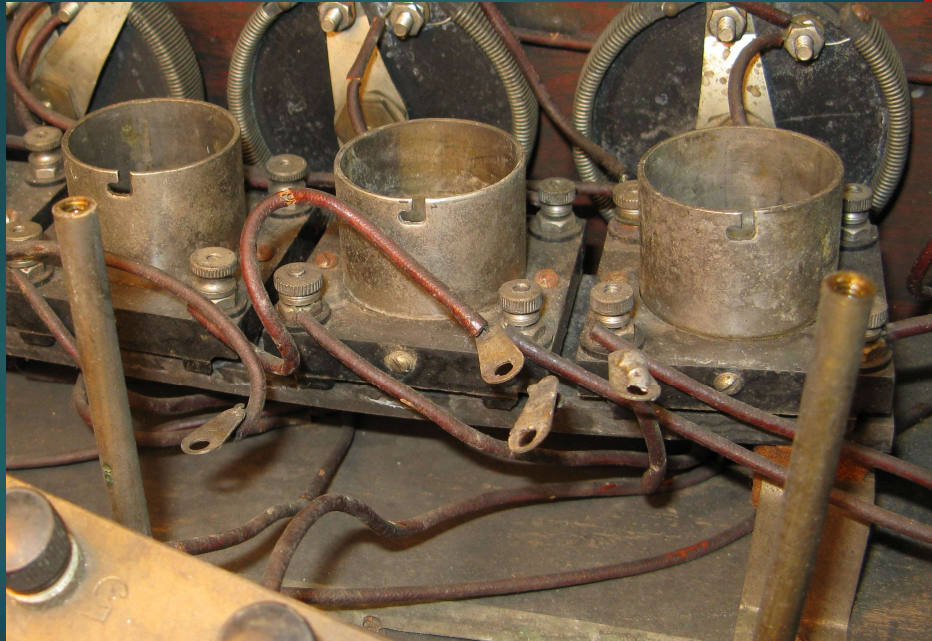
So, the warping is only one of the many problems with these surviving sets. They are completely wired with 18-gauge solid wire covered with varnished cambric tubing. All the components had to come off the panel for flattening. All the other parts of the set were equally awful with rust, oxidation and pure old crud.

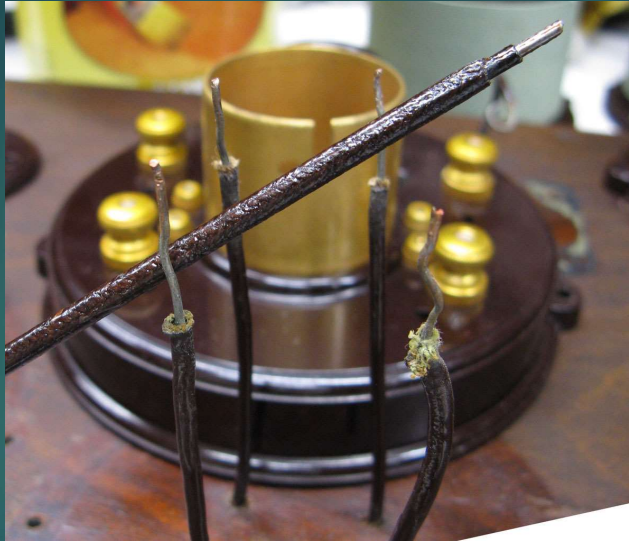
This dry rot tubing is as brittle as glass and would not respond to any cleaning at all; this tubing coating now being embedded with crud. These are scarce artifacts and I want to do my work faithful to the original.... In each radio there is some 12 to 14 feet of this tubing required! I was confident I had a solution.

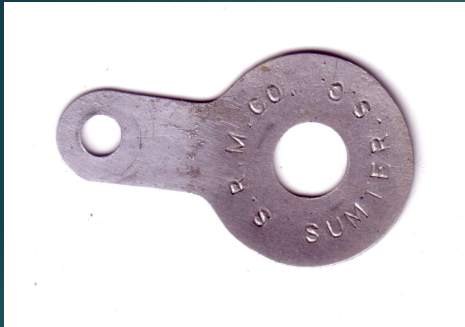
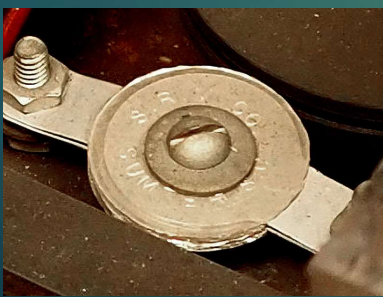
One example of this receiver has replacement transformers. A Federal on the left and a Jefferson #41 on the right... These transformers have different mounting holes. It appears that both primaries are bypassed with these Sumter branded Mica dielectric capacitors. It is presumed that the value is approximately 1,000 pf. I am not going to be able to die stamp these parts, but I can be tricky.

One example of this receiver has obvious replacement transformers. A Federal on the left and a Jefferson #41 on the right... These transformers have different mounting holes. It appears that both primaries are bypassed with these Sumter branded Mica dielectric capacitors. It is presumed that the value is approximately 1,000 pf. I am not going to be able to die stamp these parts, but I can be tricky.

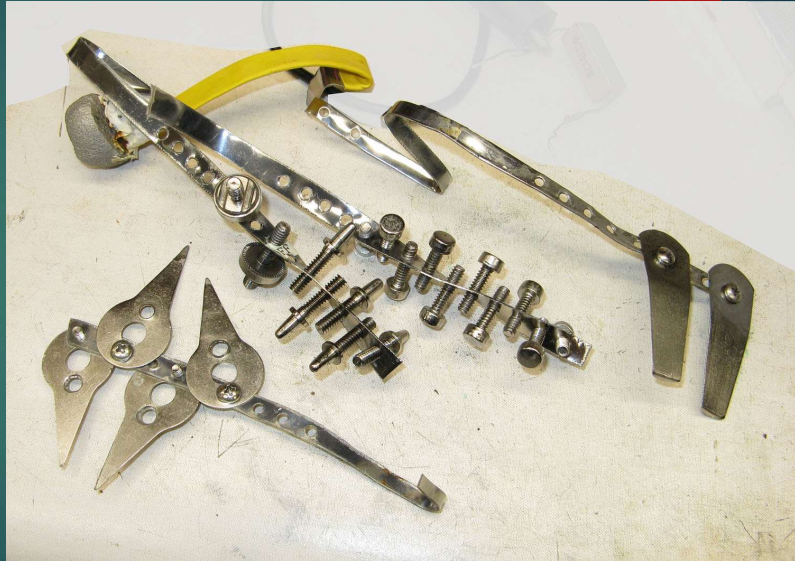
[21]

The passage of 100 years has not been kind to these radios.... Much of the nickel plate was destroyed. The tap switch replica parts needed to be polished and plated. This is a straightforward process I have done many times. The leaf contacts and knob pointers are pitted, I did not attempt to fill the pits.

The passage of 100 years has not been kind to these radios.... Much of the nickel plate was destroyed. The tap switch replica parts needed to be polished and plated. This is a straightforward process I have done many times. The leaf contacts and knob pointers are pitted, I did not attempt to fill the pits.

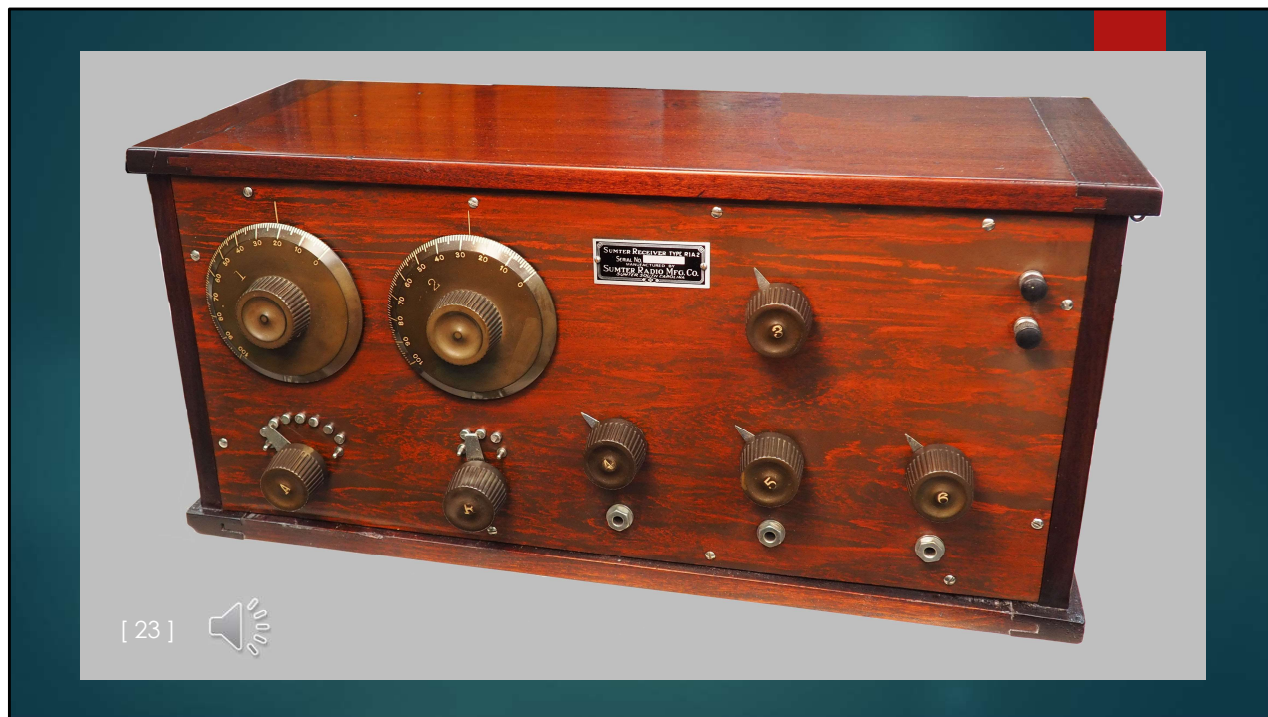
The builder plate on each of the four examples is identical and this is the best surviving example, Since this radio was going to require radical restoration, I decided to create a new graphic using Photoshop. These photo etched plates were not of the best quality to begin with.... I spent considerable time in determining the true boundaries of the hand drawn text. I had presumed that a modern recreation of the plate would be done on a laser engraving machine. A job shop suggested that a dye-sublimation print would provide an accurate results. To make a laser etched plate would have required a couple hours of professional manual labor to produce a vector graphic required to guide the laser. I think the results of the dye print will be satisfactory.

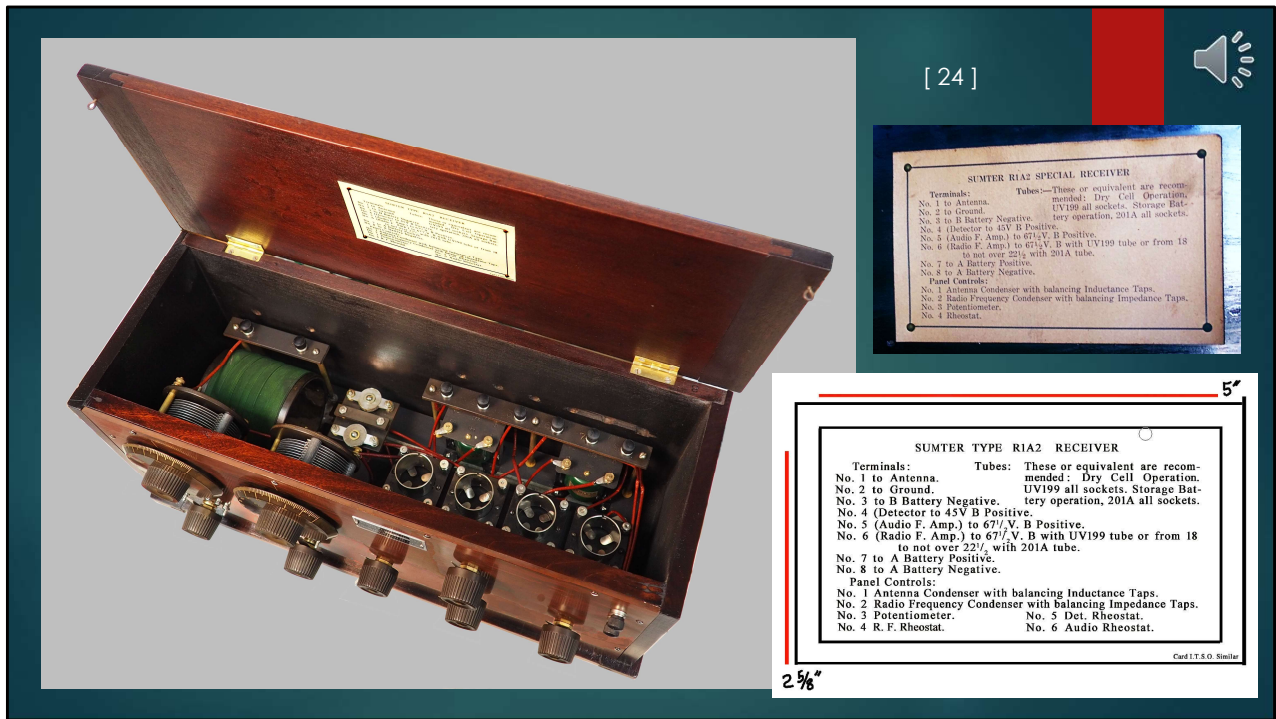
The undated Sumter newspaper article states that the cabinets are finished in mahogany color. When found this cabinet had already been partially stripped. In cleaning, I was able to determine that a brown mahogany stain had been used. The actual wood is presumed to be gum wood. A wood that had been used in the old Sumter Telephones. The 1909 postcard details a wood shop in the complex. I don't know if there was a wood shop in operation in then. The hard rubber knobs are actually black hard rubber. Here going after all the oxidized rubber would have eliminated the numbering. One surviving example has identical knobs molded in the same faux mahogany colored hard rubber. So, I had restored the chassis and the cabinet and after weeks was finally ready to slide the chassis assembly into place and discovered that the panel would not fit.... With all my careful work, I had failed to note that the top-left corner was out of square enough to completely prevent four panel screws from going into place. After three to four hours of labor over two days, I had a workable solution....
