I acquired an example of this radio two months ago. It has been repaired to make it operational. But I have yet to power it up. What I do not like is that some repairs have been done in an expedient way. I am compelled to try and correct some of them.

So here is my new-found 30W.... Certainly nothing even remotely equivalent to American made radios of 1929 produced in any quantity at all. The large thumbwheel knobs on the front are for regeneration and tuning. Small shafts on either side of the cabinet provide friction drive for fine adjustments. A three-position slide switch on the front selects operating wave lengths from 200 to 2000 meters. To operate the set, you must lift the lid and press the white button. To turn off, you push the Black button. No real shock hazard and these three tubes do not get dangerously hot The power rectifier tube is enclosed in the metal box.

Presented by : Robert Lozier – KD4HSH

kd4hsh@carolina.rr.com --- December 2021

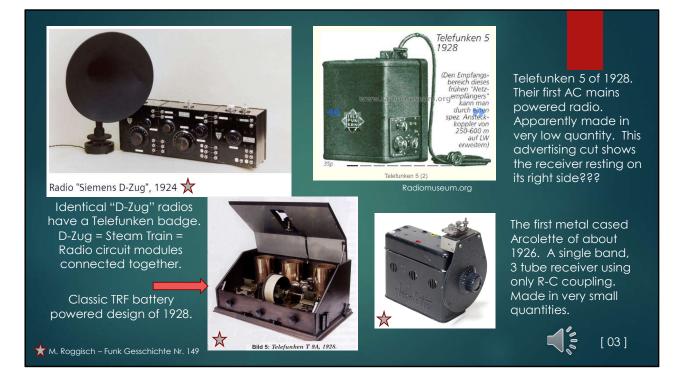
These are Telefunken branded radios from 1924 to 1928. The unit panel radios called D-Zug radios were made in small quantities on the heels of Germany's period of hyperinflation. Only a few of the very strange looking 3 tube Arcolette battery radios were made around 1926, the first to use R-C coupling providing enough gain to drive a loudspeaker. Broadcast receiver manufacturing rate increases considerably in 1927, producing some very nice TRF and Neutrodyne radios. The very odd-looking Telefunken 5 of1928 becomes their very firs AC powered broadcast receiver but production numbers were very low.

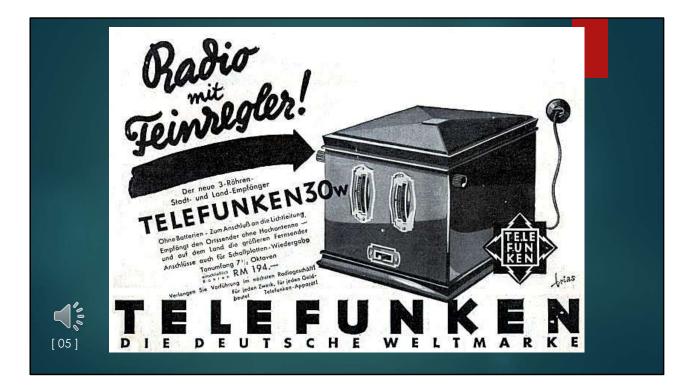
Radio with Fine Tuning! Boasting 7 ½ Octave tone range. Telefunken, the German world market brand.

This series of radios were exported. Here are advertisements in Dutch and Italian with line drawings showing appropriate loudspeakers. The diminutive Philips 2016 plain parchment cone was also available at some time with several chaotic color motifs. I kind-of wish I had one of them. I have had one of the boxy, plain Jane looking Arcophon 3 speakers shown on the right for 25 years but never researched it. Only this past week did I learn that it has a very unusual radiating structure consisting of two half cylinders of a parchment like paper joined along one edge and attached to the pin driver mechanism. I'll certainly want to see how this sounds.

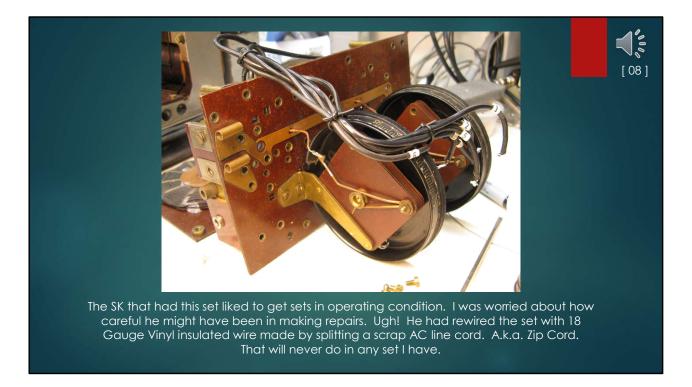
The Silent Key that had this set liked to get sets in operating condition. I was worried about how careful he might have been in making repairs. Ugh! He had rewired the set with 18 Gauge Vinyl insulated wire made by splitting a scrap AC line cord. A.k.a. Zip Cord. That would never do in any set I have.

My way to duplicate vintage rubber covered wire is to use UL3132 soft silicone rubber wire available on e-Bay. Increase the diameter by using 3/32" diameter 2:1 shrink ratio thin-wall heat-shrink polyolefin tubing. This tubing is available in various colors and can be stained with aniline wood dyes such as Mohawk Ultra Penetrating Stain to make the wiring look aged.

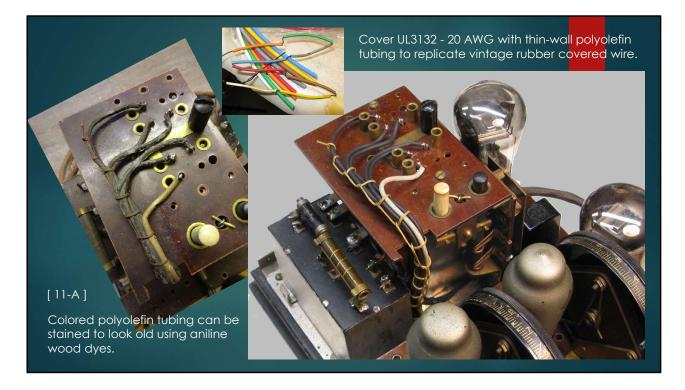
Odd that you make specific requests and people send you pictures of obvious modern plastic insulated wire. Thankfully though, one person responded as requested.... I use Photoshop to boost the color saturation as high as possible. Sometimes that will show some of the original tint. In this case, it appears that all five dark colored wires are simply black rubber covered stranded wire of about 20 AWG. One wire is natural white rubber. They assembled a cable with likely waxed linen cord. Easy to replicate.

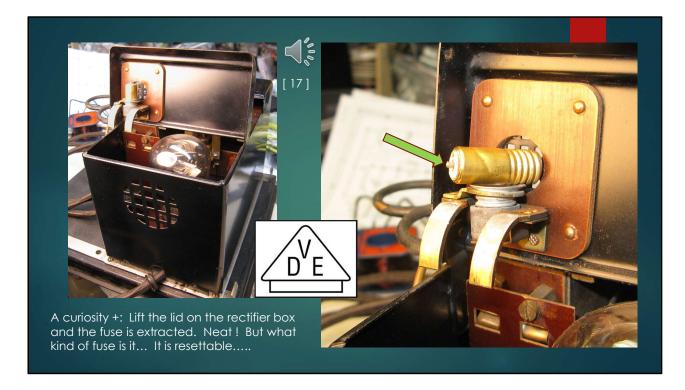
The German equivalent of Underwriters Laboratories was/is VDE and for the late 1920s was more cautious for consumer electrical devices than here in the USA, You see precautions like this where opening a lid disconnects any circuits you could touch with a "standard finger probe" There had to be a fusible device inside the radio. In this case, it is a resettable thermal fuse. The brass tube has a ceramic bead with a spring-loaded brass pin with a piston like head inside. The spring is surrounded by hard wax. If the area gets hot enough, the pin will withdraw inside the cylinder and break the line circuit. The service man could heat the fuse gently and push the pin back out from the other end and allow to cool until the wax hardened thus resetting the fuse.
