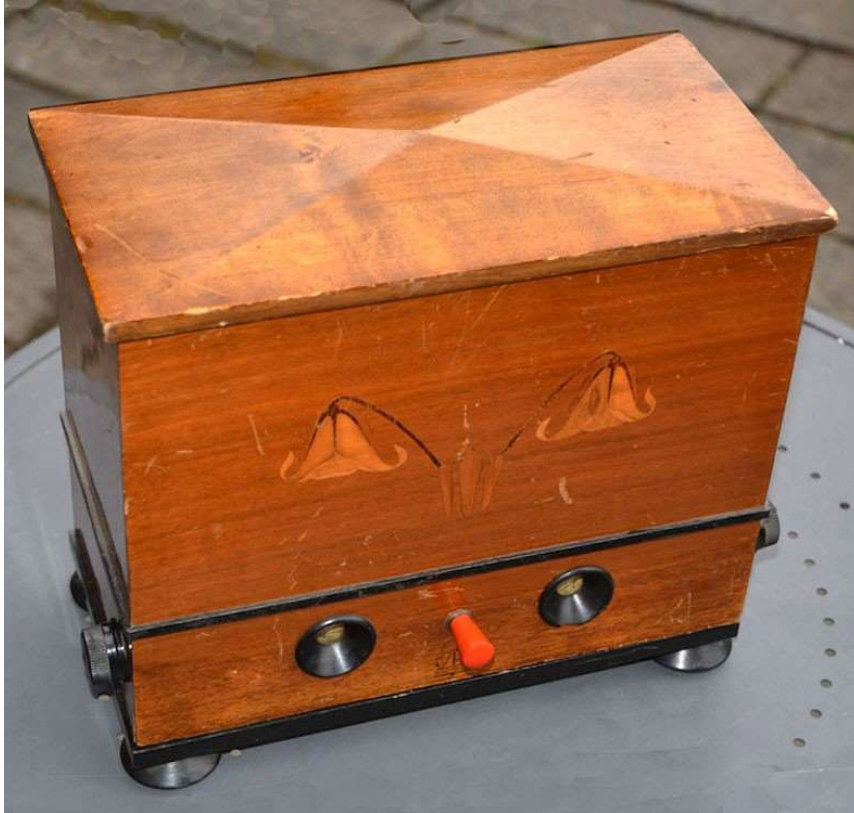
attempted to make a replacement. His base plate was not quite large enough and was attached crooked with countersunk flat head screws. The cabinet sides and top had dozens of deep scratches and dents that severely degraded the appearance of the set. **The battery cable had been cut off.** But the

good news was that the receiver chassis still had all original parts. One audio transformer tested OK but the other transformer has an open winding. However, that is OK with me; they were never designed to last 90 years. **What is important to me is to preserve original components.**

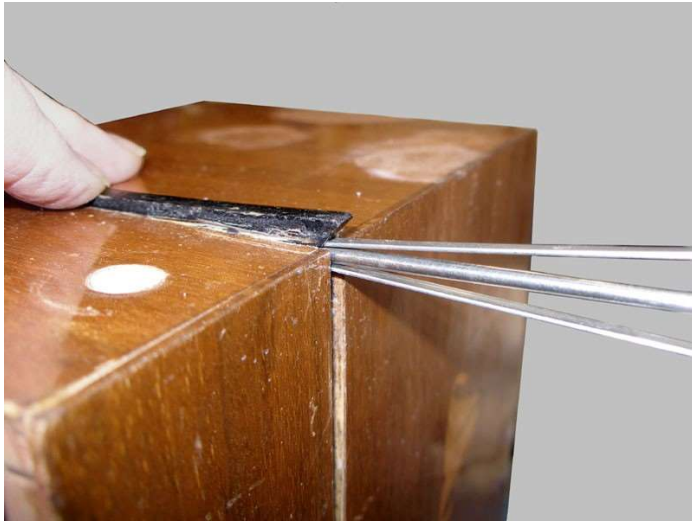
The photograph shows my removal technique. The flat Stainless Steel strips are salvaged from a used windshield wiper blade and the end is ground down to a dull wedge. They are driven into place one at a time; this protects the cabinet and the part being removed. Then a skinny flat blade screwdriver is driven in between to complete the extraction. This technique works well when opening an old locking rabbet box joint commonly found on radio cabinets.

wood strips without showing external damage. It involved driving very thin razor blades down beside the strips and driving flat SS strips in from the ends to lift the strips from the bottom of the grooves. Fortunately the repairer had not done a completely thorough job of removing the old hide glue

from the bottom of the grooves so that I could still weaken the bonds to some degree with water but it was a terrifying task.

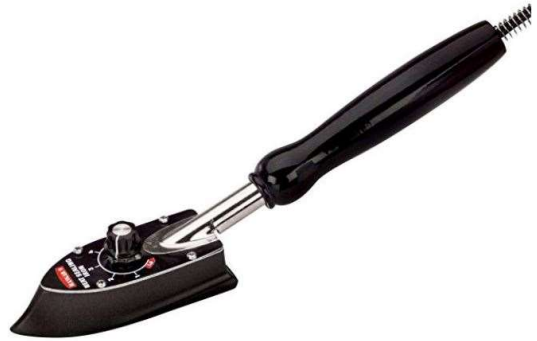
I have an old heat-sealing iron as used for mounting photographs and prints. You can buy a new one with adjustable temperature for about \$25 from e-Bay. This tool works well for steaming dents simply because of its small size. You could use a full-size iron, but its heating area is much larger than you really want for working on small dents.

The process is easy, just take a small square of old cotton bed sheeting and lay it on the wood. Use a disposable pipette to apply a few drops of water to the sheeting. Apply the iron for ten seconds or so and then lift the sheet off. There will be condensed steam on the finish around where you are working that you will wipe off. You repeat the process two to four times but before each new placement of the sheet, apply a few drops of water directly on the dent and allow it to soak-in for a minute or so. Then apply the sheet, add a few more drops of water and steam until the sizzle stops. I have found that performing more than three or four applications will yield little improvement. There can be a great variation in the effectiveness of this process but in this case, it proved well worth the effort.

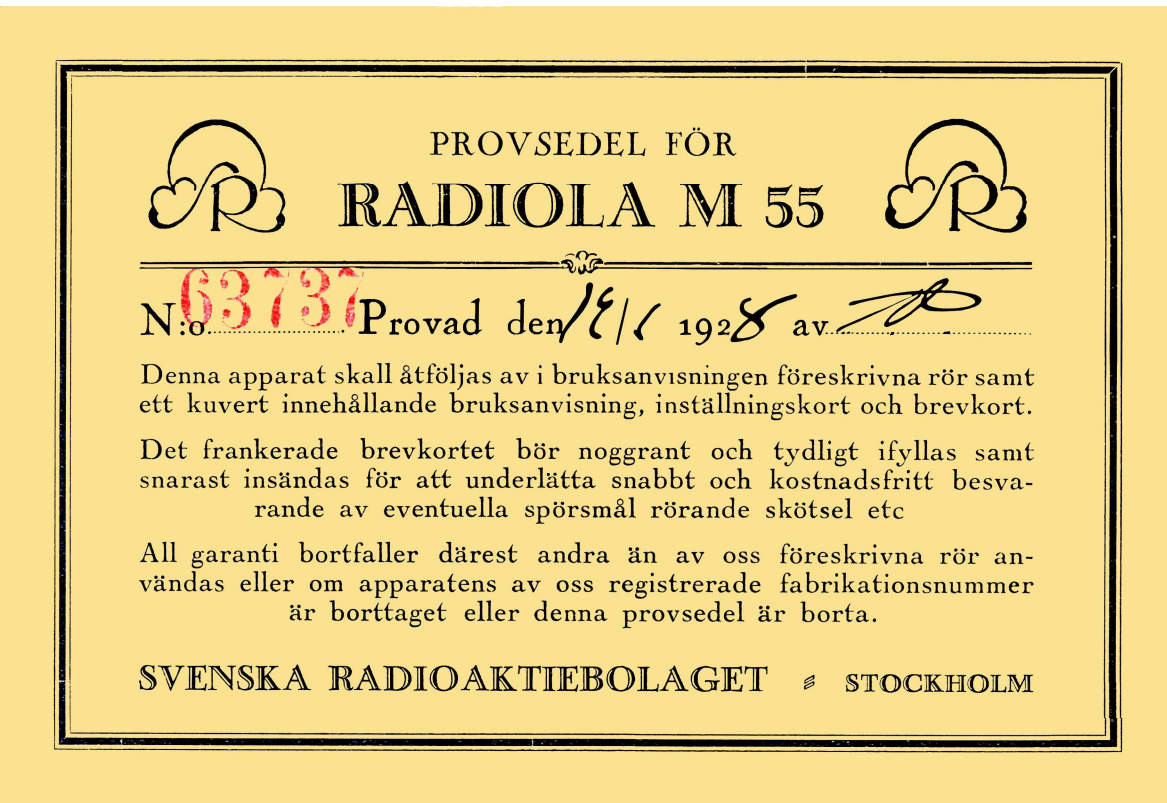
3. Since the base for this radio was not original, it was missing the paper label pasted to the bottom. I could not place the bottom of my reference M55 on a flat-bed scanner because the feet are glued in place. This time I did not use it as simply a template for placement of computer generated text; which is the preferred method. After 13 years, I had just purchased a new Olympus OM-D E10 Mark II camera and was able to make a very sharp photo that could be retouched. As mentioned earlier, for some reason the

label on my first M55 had been deliberately defaced. I was able to ask my Swedish friend to take snapshots of other M55 labels and from them I could reproduce the areas that had been defaced.

There is no way to know the serial number of my particular radio but I could use a number in the series and simply transpose a couple of digits to make my unit likely have a unique serial number among the sets that survive after 90 years.

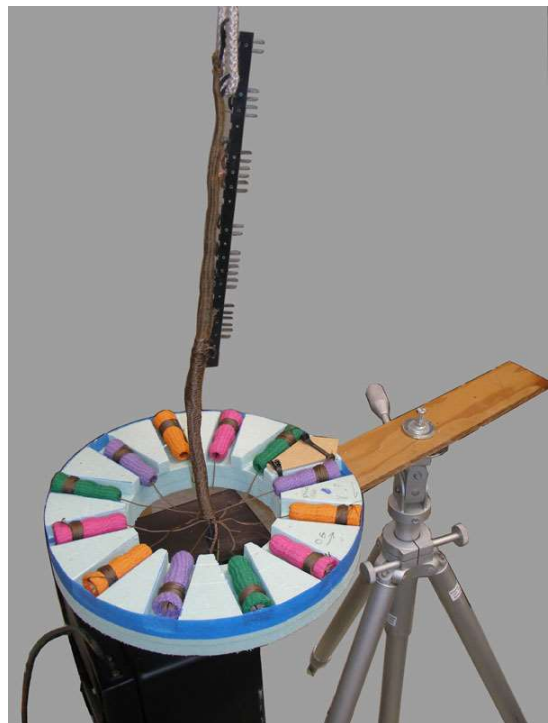
Using just 12 bobbins to reproduce this particular M55 cable is somewhat less convincing but only if you have an original next to it for A/B comparison. I think the substitution will not materially detract from the overall appreciation of this receiver. I began to think about how I could improve my braiding

scheme. The work I had produced was too uneven and loose despite my best efforts.

There is a wood eyelet to support the cable as it is braided. It is actually split in half and only held in place by the two plywood sheets connected to the ring. Should you be interested in the details, A full description can be found at this URL: <http://kd4hsh.homestead.com/Cable-Braiding.html>

position. I found that mounting the ring to a camera tripod was easy and worked very well for me. The total braiding time was 7 or 8 hours spaced over 5 days but I think I wound up with a cable that greatly enhanced this particular radio.

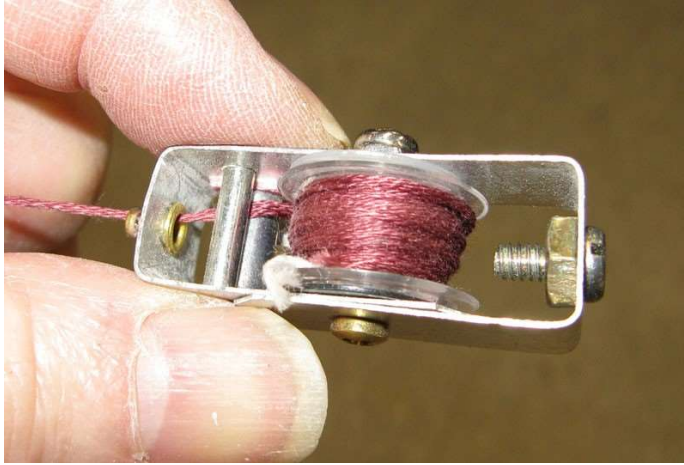
My idea was to make little shuttles containing a thread bobbin with a foam rubber flat washer acting as a drag plate on the side of the bobbin. I knew from sewing machine technology that this is not a good way to keep constant tension on the thread because as the

thread is pulled off the bobbin, the amount of pull required to cause the drag plate to slip increases, thus making your braided jacket tighter. But I could not think of a way to make a simple tensioning device independent of drag on the bobbins with the materials I had in the shop. However, the changes made did substantially reduce the strain on my fingers. BUT the work I could produce still looked uneven in a different way and **actually looked worse.**

By this time, I had spent almost a week of afternoon hours fiddling with this problem; **but I just could not accept defeat.** I finally thought of a simple way to put drag on the thread independent of the bobbin. My solution was to have a steel rivet pass through the cage. A small super magnet was positioned to adhere to the side of the rivet. Thus, if the thread was placed to run between the rivet and the magnet, it would pinch the thread and provide a fairly constant drag regardless of how full the bobbin. Drag can be regulated by wrapping the magnet with a few layers of aluminum foil tape. **It worked!**

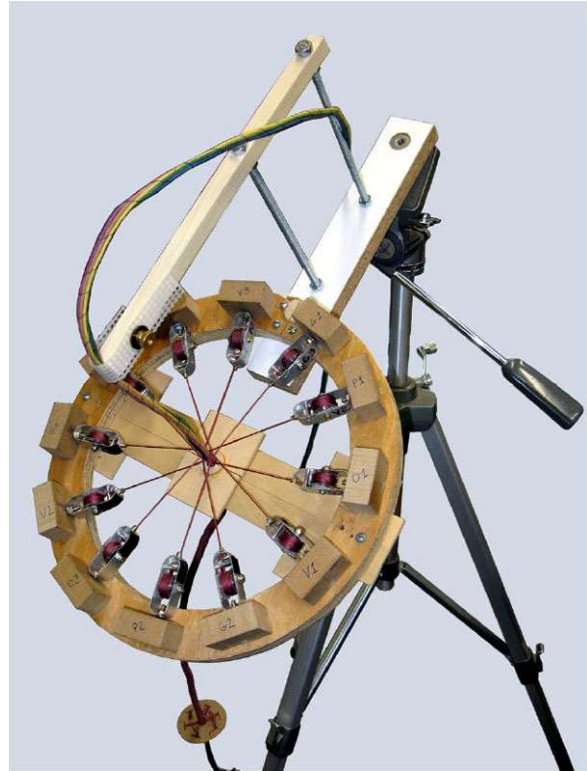
I needed a frame to keep the bobbins in order and apply tension on my wire bundle. The solution was to cut a ring from scrap plywood. Glued to the top of the ring are 12 squares of MDF board.

There is a 6mm hole drilled in the side facing the center of the ring. I press fitted another super magnet as used in the shuttle into each hole. This provides a magnetic anchor to the #6 steel flat head screw in the end of the shuttle frame. The MDF block keeps you from accidentally pulling too much on the shuttle and introducing slack in the thread.

The braiding sequence is to begin at the top of the ring at V3 and move the shuttle CW to position P1. The shuttle previously occupying P1 is shifted CW to V1 and so forth until you are back to the V3 location. (i.e. You have moved every other shuttle clockwise.) Then you grasp the G1 shuttle and move it counterclockwise to the O3 position, the displaced O3 shuttle being moved CCW to the G3 position and so forth back to G1. This creates 0.5 mm of braid length. Since you are moving the shuttles a few thousand times, you want to be in a comfortable working

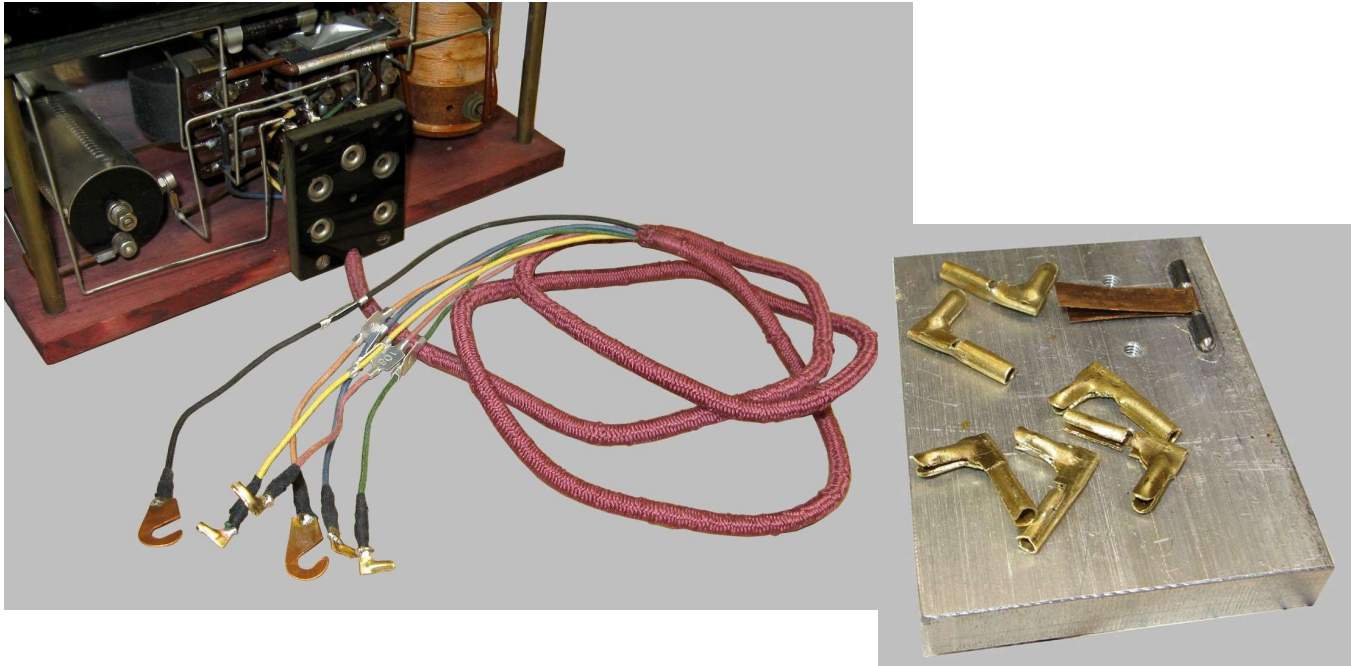
6. Each wire has a little aluminum tag to identify the voltage it

should be connected to. Replica tags were made without too much difficulty.

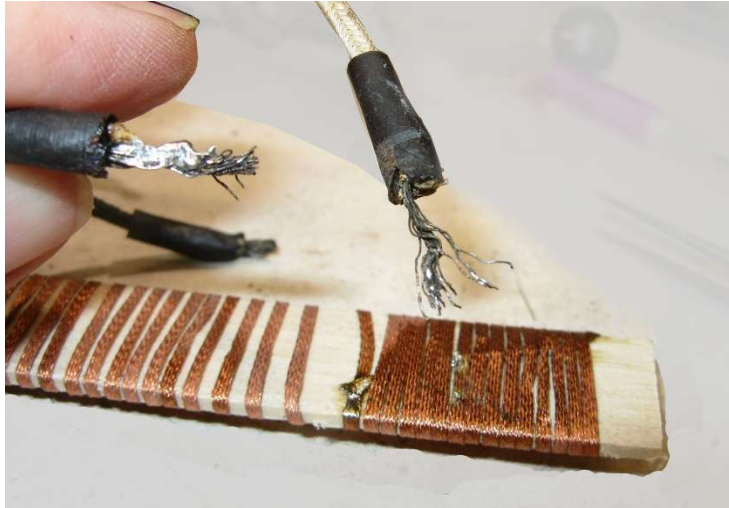
Battery cable in better shape than expected only fraying on both ends... Only necessary to whip both ends. As it turned out, it was time consuming to repair a splice on the -16 & A+ leads. The stranded wire was not twisted before soldering and in removing it, the wires were helter-skelter.

I made up a pad of Solder Wick by wrapping around a thin strip of wood. Saturated the wick with rosin flux, laid the wire on the pad and place the tinned soldering iron tip on top. Then I can drag the wire between the pad and soldering iron tip to

remove excess solder so that the fine strands could be separated and straightened. Seems to be a safe way to do this. After individual strands are straightened, I can brush them with a very fine glass fiber clockmaker's brush pencil. The strands can now be properly twisted and tinned.

The colored braid on individual wires was in very good condition except for one wire... I was able to wrap the frayed portion with plain cotton cord. To get the proper color match to the aged braid, I found that I could rub the new cord with 'oil pastel crayons' and then brush the cord with a stiff bristle brush only very slightly damp with alcohol. The color match becomes good enough for even a critical exhibit observer to likely never notice the repair.

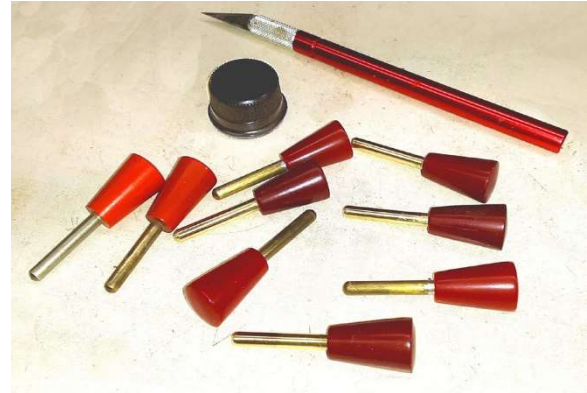
There is a red topped brass shorting pin used to select tuning ranges, bypass the regeneration and turn ON the tube filaments that are missing. Making a silicone rubber mold for this part turned out to be a bit of a challenge.

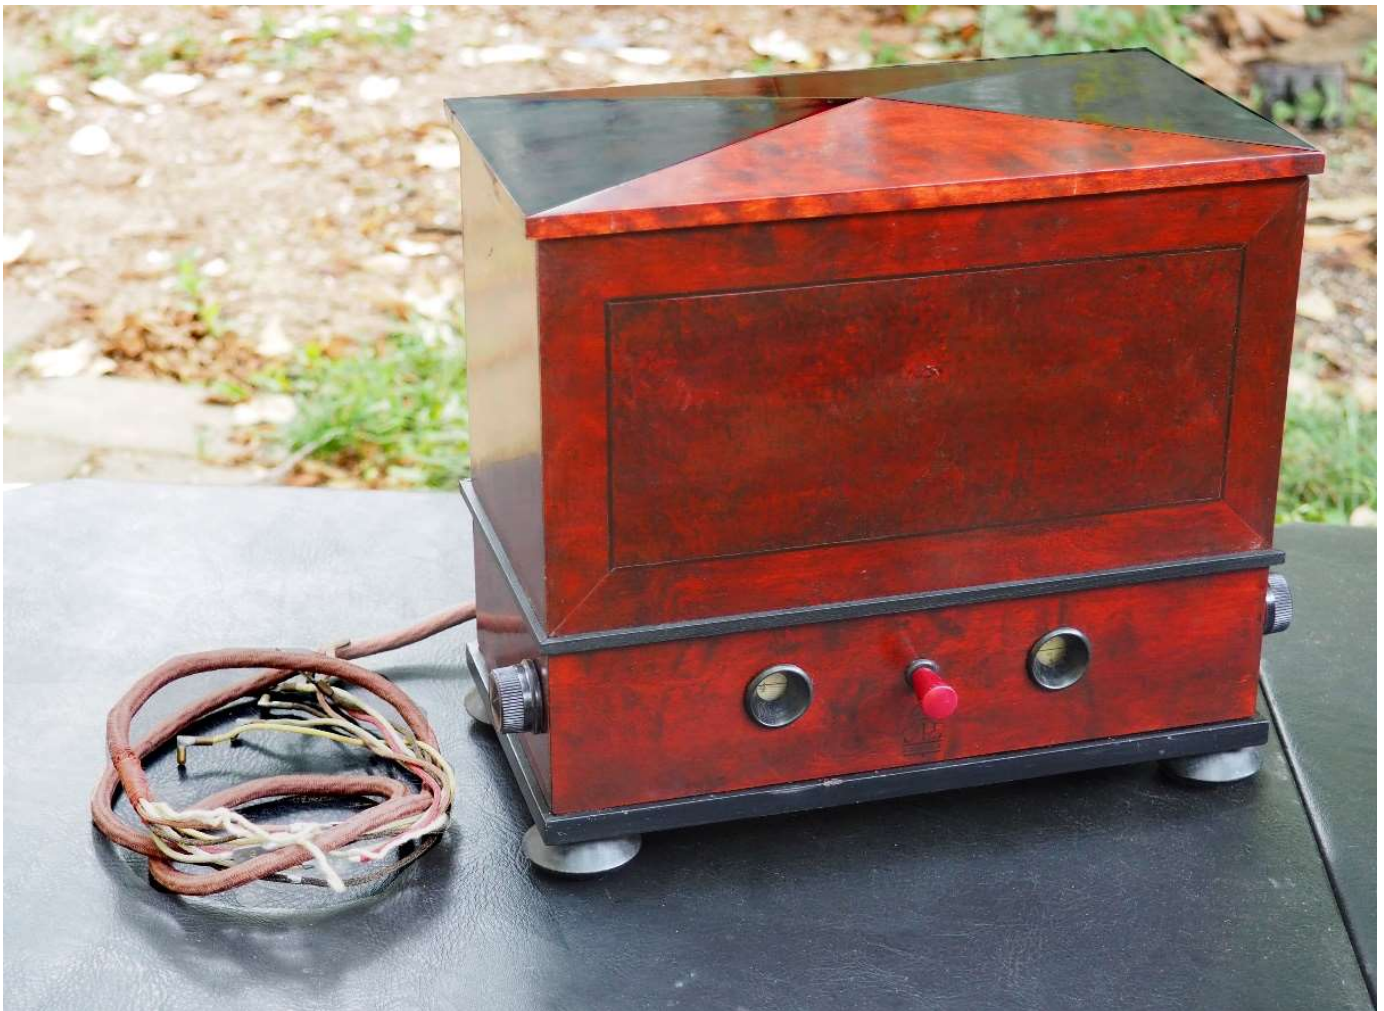
After three weeks of afternoon work, this is the result.

I note that this cabinet is very difficult to photograph. Under indoor lighting conditions it appears very dark indeed.
