A dog of a Zenith 3R to make presentable.

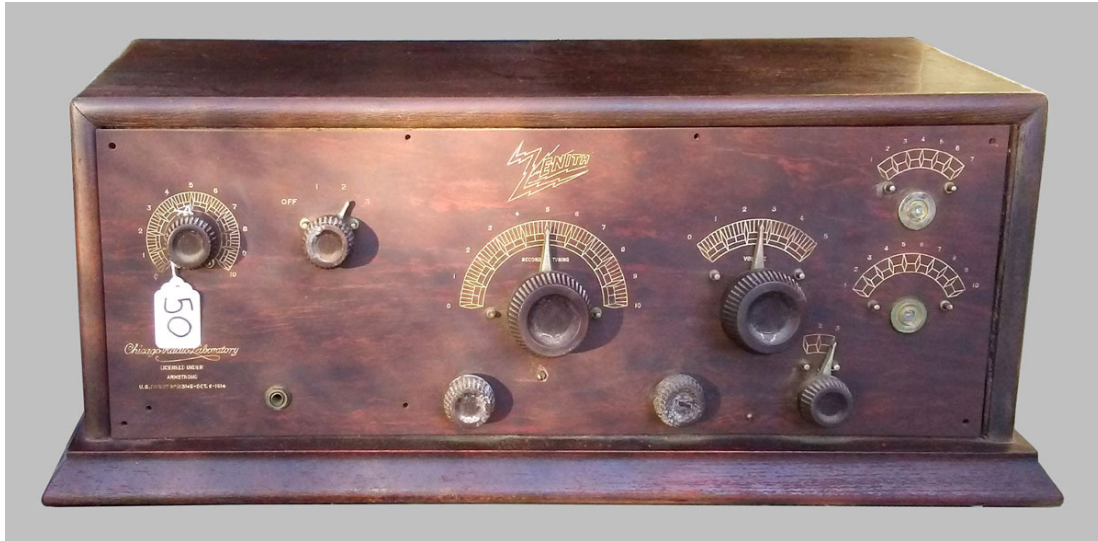
Sort of deceptive when looking head-on to the panel.... Yes, there are two knobs missing and three pointers but how bad can that be? Get it into the shop and start looking closer... I start to itemize the tasks; the list has 25 items! , over a dozen tasks I've never had to face before and I suspect few people have ever taken on these tasks. I take as many close-up pictures as possible from every angle I can figure. These pictures ALWAYS bail me out in the end when I realize that my notes and sketches made for reference have critical omissions.

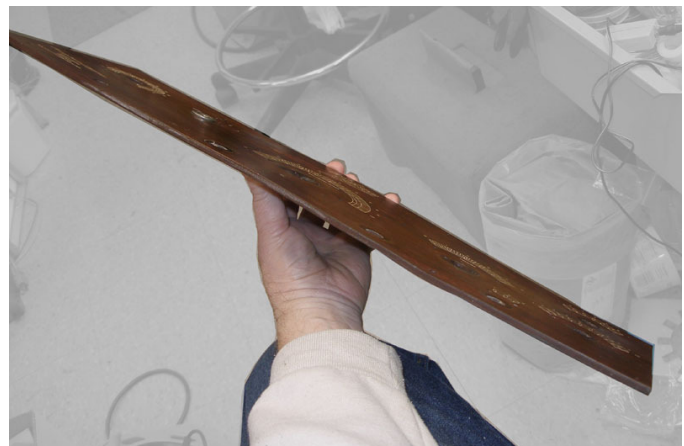
1. The hard rubber front panel is warped and cupped way too much to be ignored; got to flatten it: With just about any other 1920s radio with a Bakelite or hard rubber panel, all that is necessary is to remove an assortment of screws and lock nuts; not so with this Zenith. There are 9

parts that are press fit brass bushings into large washers. Getting them off without damage is not easy and cannot even be attempted until you deal with pot metal knob shafts that have broken off in the brass bushings.

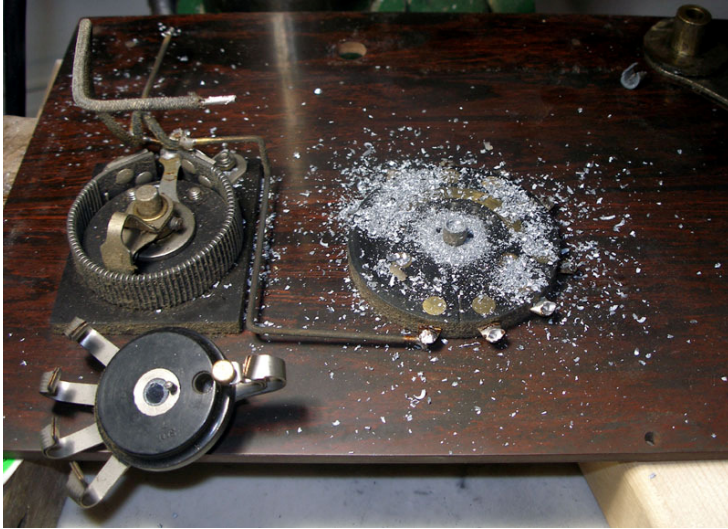
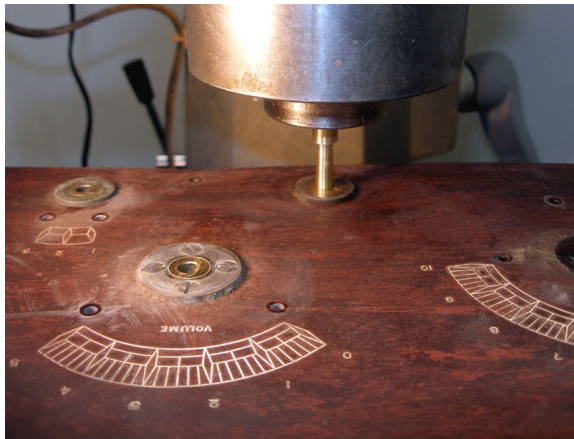
2. All six pot metal shafts were frozen in their brass bushings and 3 broken off: I had to very carefully drill the pot metal from the bushings finishing up by reaming the bushings to 0.251". I would have preferred to drill out these bushings on the lathe after extracting them from the panel but I feared bushing extraction would be

complicated if there was not a pilot pin going through the bushing while being pressed out. It was one of those 'chicken or the egg' kind-of problem.

3. The press-fit knob bushings have to be pressed out of the panel so that the panel can be flattened and the press fit washers replated: This was something that had to be done by applying perfectly aligned vertical pressure. Off center pressure would, in effect make the washer inner bore and the contact

point of the bushing elliptical thus destroying the remaining strength of the press fit. Basically I had just one chance to do this operation correctly. An arbor with shoulder was turned to fit exactly in the bushing bore and I used the quill of my milling machine to apply just the right amount of downward pressure to extract the bushings.

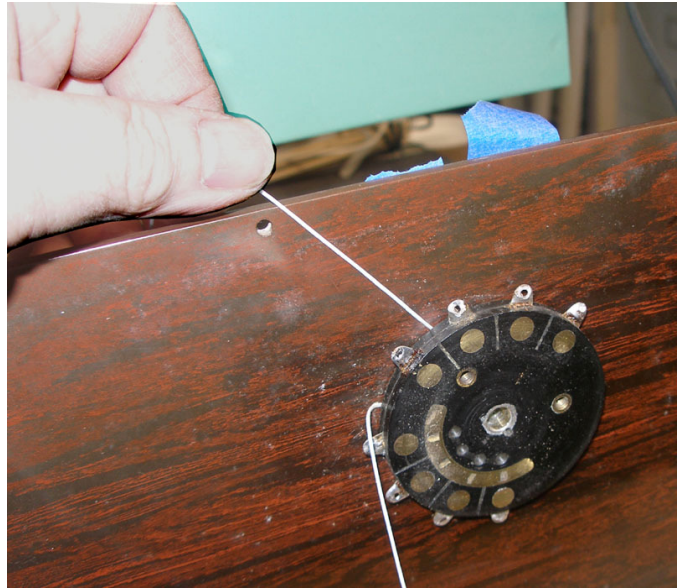
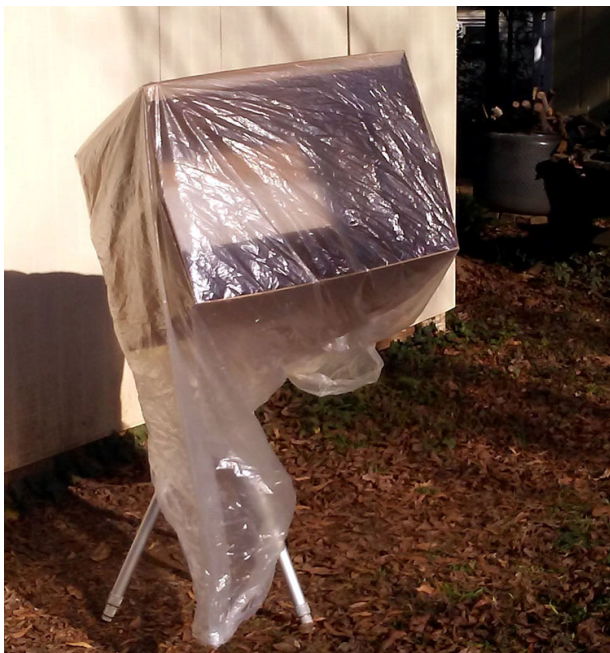
The amplifier selector switch presented a special problem. The switch bushing could not be pressed out in the same fashion but had to come apart.

The solution turned out to involve forcing a 0.5mm Kevlar braided cord down between the body of the switch and the panel. The very small deflection of the panel or the switch body was not enough to crack either one. Once the cord was pulled down to the center, another wrap of cord was added and again pulled tightly down to the center. This increases the separation force. After wrapping 6 or 8 turns, the force was multiplied enough to separate the parts.

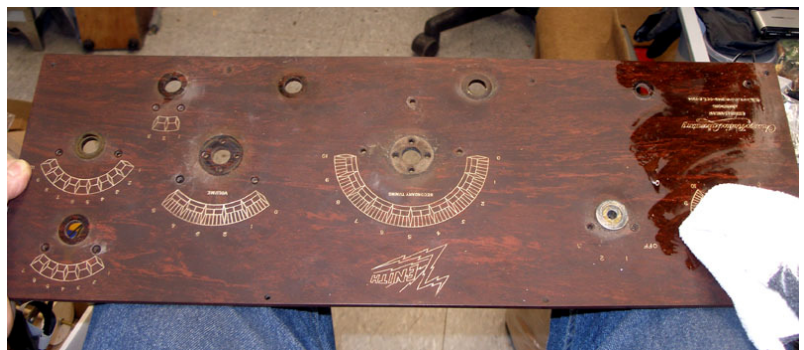
4. Refinish the engraved front panel: The filled engraving was almost complete and in good shape. The hard rubber panel was originally a glossy faux mahogany grain finish.

The effect is created by extruding the sheets using lumps of varying color hard rubber. i.e. The color goes all the way through like industrial vinyl floor tile. Unfortunately the mixture of materials does not present the exact same aging characteristics, especially regarding its resistance to cleaning with water based cleaning solutions. The net results are that the surface becomes rough.

You do not want to use any water based cleaners on hard rubber. I begin with a cleaning of Go-Jo waterless hand cleaner. I have found that you do not want to leave it in contact with the panel for more than a few minutes... Put it on, rub vigorously with terry cloth or 0000 steel wool and then wipe as much of the material off as possible. Finish off by rubbing with a cotton cloth very slightly damp with mineral spirits. In the case of this panel I found that it needed further polishing. I did it with materials in a Turtle Wax automotive lens restoring kit. Be aware that this does have some risk of imparting a faint white haze to some parts of the panel. If

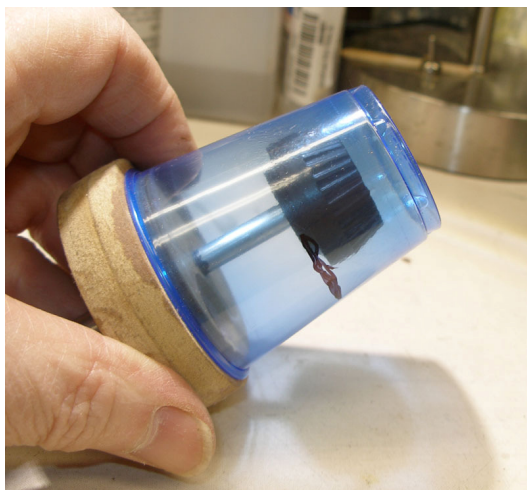
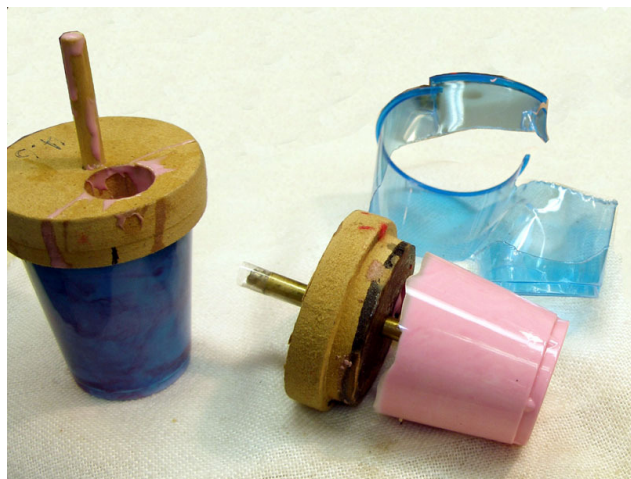
5. I had to make two knobs: I've made silicone molds and cast urethane knobs to mimic hard rubber before. I had made silicone rubber molds for the Zenith knobs some 35 years ago and still had them. However on inspection, I found too many flaws in the way I had cast the molds to meet my current standards. My current method for making molds is pretty easy. The most critical thing is to make sure that there are no bubbles in the liquid rubber. The Zenith knob has a deep recess in its face. Air bubbles can (and will) get trapped in this area and will rise up against the surface of the part. The liquid rubber must be degassed with a good vacuum pump. On curing two things will happen: Either the bubble will be torn open when the sample knob is withdrawn leaving a hole in the wall of the mold. Or if the bubble remains intact very close to the surface and virtually invisible at the mold surface; when liquid resin is poured into the mold and begins to cure, it heats up. The heating causes the trapped bubbles to expand. The net result is that the cast part will have concave recesses where the bubbles expanded. Not good....

The Zenith knobs are made of hard rubber and were originally glossy black. However over time the surface oxidizes and turns brown. I know of no effective way to color the surface of the knob with a black dye, although I have tried many ways. I think I tried spray painting the knobs with black lacquer one time. My

My solution is to use a two part, polyurethane casting resin colored by a blend of black and brown dyes made especially for the resin. I use Smooth-Cast products. To get the right coloration requires careful measurement of the weights of your resins on a gram scale. The dyes come in bottles with a dropper nozzle. You very carefully squeeze-out the number of drops of each dye for the given weight of resin. (You need to be aware of the room temperature. The droplets will be larger for materials in a cold room. Most resin performance is specified for a room temperature of 73 F.) With some experience, you can determine the correct volume and combination of dye droplets to get the desired color after casting two or three parts. These casting resins require the same vacuum degassing after mixing as done with the silicone rubbers. After the degassed resin is poured into the mold, the mold is placed in the vacuum chamber and degassed again and the vacuum relieved before the resin starts to harden.

These knobs are actually held in place by the pot metal pointers. The pointer has two countersunk #4 screw holes. So you have to tap the knob for two 4x40 flat head screws in the back of the knob.

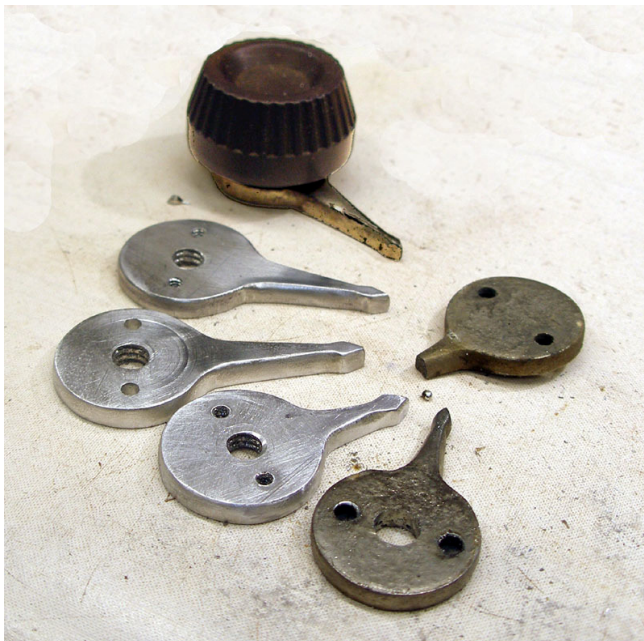
6. One small pointer and two large pointers were broken off short or missing completely: The originals are nickel plated die cast pot metal. Others have made replacement pointers from aluminum; I did this as well. Cutting out the blanks is no big deal. The real pain is in filing the

sloped edges of the pointer with jeweler's files. In my desire not to spoil the blanks by too much file work, they are not quite slim enough to match the originals. So I will admit there is room for improvement here.

Coloring aluminum in the shop to match the five surviving pointers is difficult. Anodizing in the home shop is possible but definitely takes time and money to set up and the chemicals required are hazardous. My solution was to spray the aluminum with decorative nickel lacquer and follow by applying a tiny amount of black aniline dye with a gauze pad to daub on to the part and rub to achieve the right look. Since these parts are not subject to abrasion, they ought to look pretty good for a very long time.

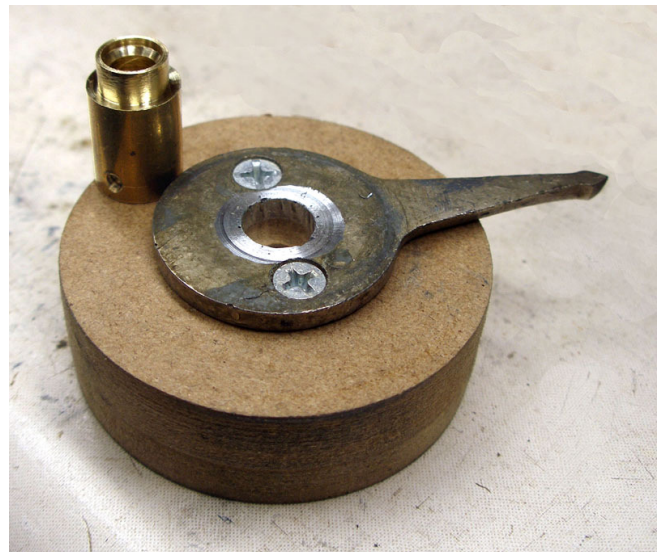
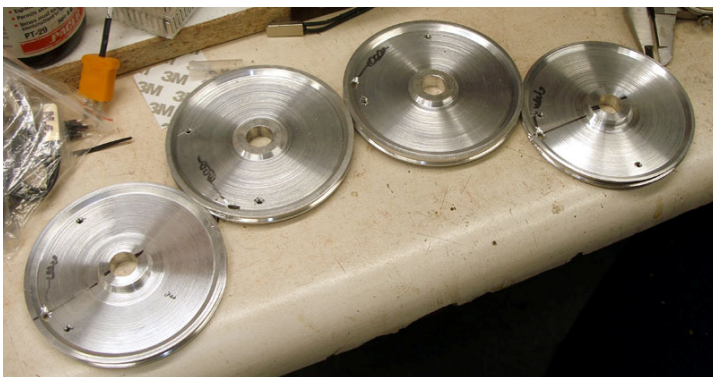
7. The pot metal secondary tuner pointer shaft bushing has crumbled apart: The pointer was still OK and I wanted to keep it if possible. I was able to mount it in the lathe and machine off the remains of the crumbled bushing and drill and ream a true 3/8" diameter hole. I used a length of 1/2" diameter brass rod to make a new part that could be swaged onto the old pointer.

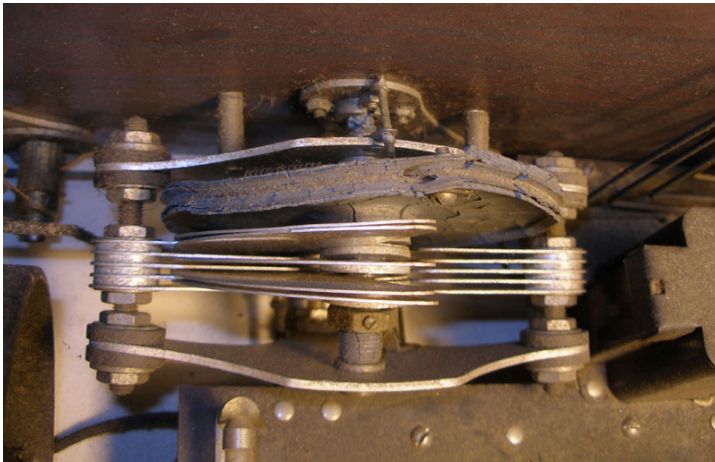
8. The two 3-5/8" dia. pot metal pulleys are totally useless. Others have machined parts from aluminum; I did the same: I took the extra time to duplicate the finer points of the part profile. When

finished, I decided to paint the parts to make them look more like the die cast original parts; something others don't seem to do. I wonder why? It is easy to do.

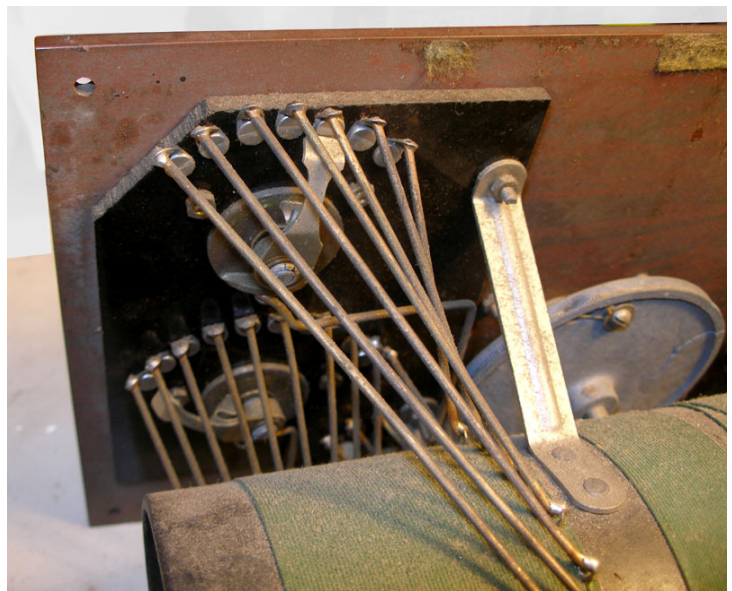
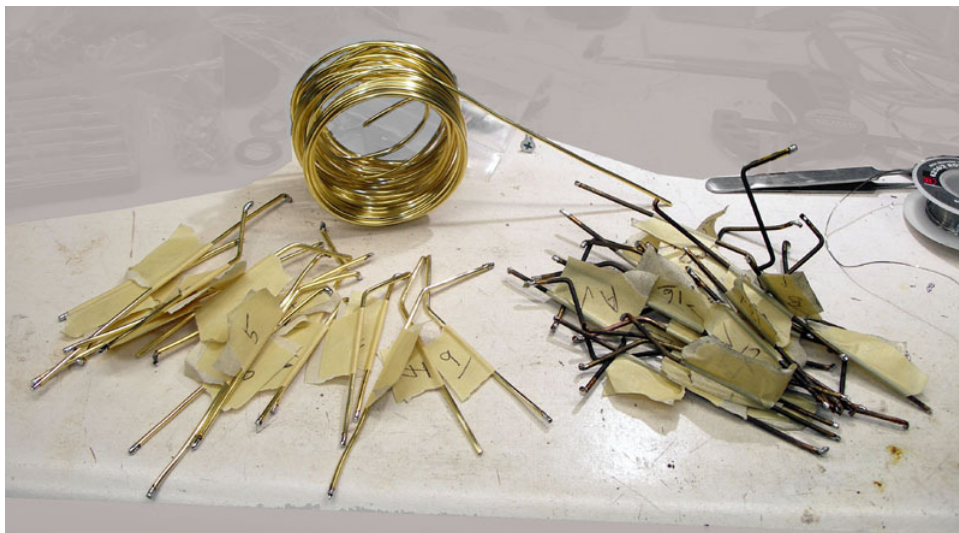
10. The gold plate on all the tuner wiring has been lost due to oxidation of the copper underneath. The remaining gold flakes off on any attempt to clean the wire. The 12 gauge gold plated buss wiring was a sales gimmick for Zenith. Unfortunately it appears that the gold plating was made directly over the copper core. In modern

times, people who know something of printed circuit board fabrication know that you really must nickel plate the copper and then plate gold. The nickel barrier prevents gold diffusion into the copper and seals the copper most completely from atmospheric oxidation of the copper. I discovered that 12 gauge, copper-core, gold plated wire is used in jewelry crafting. It is advertised as a copper core plated with silver and then plated with gold. That was good enough for me... A 25 foot roll was available on-line, delivered in the mail for under \$39. I replaced all the wiring. It

Each wire was carefully removed and new replacements bent to precise dimensions. As I recall, there were about 28 lengths to fabricate.

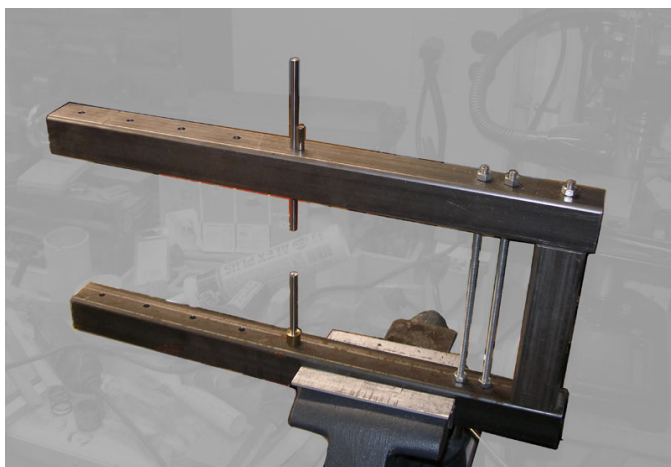
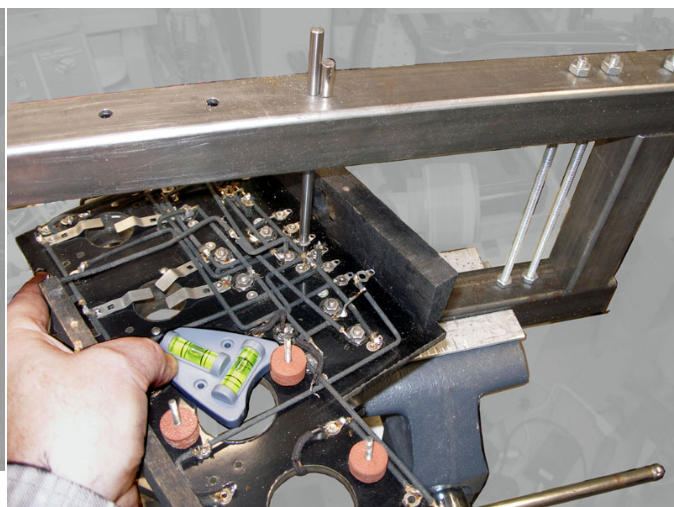
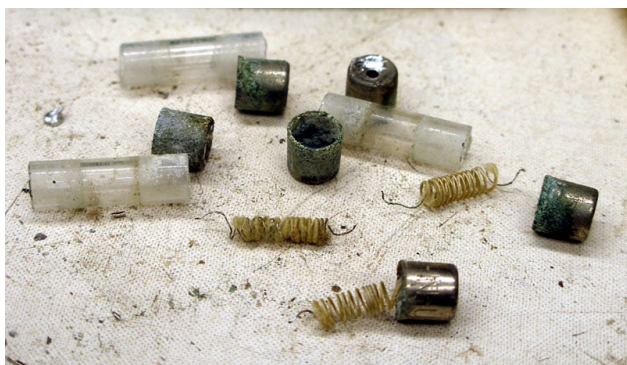
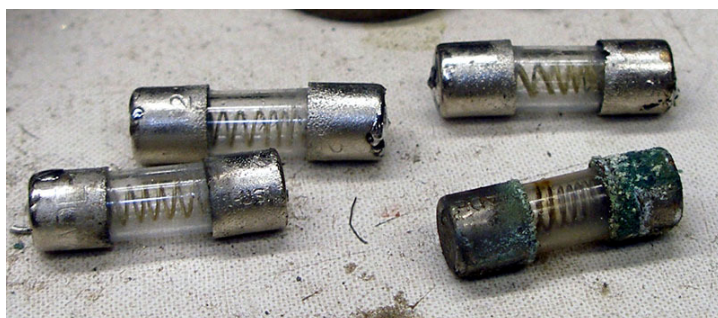
11. There are more than 40, 1/8" dia. semi-tubular rivets used in the radio. More than 30 of them cracked where they were staked or break off easily if touched. I made up a punch and die frame from 1 1/2" square heavy wall steel tubing to set the rivets. The exact rivets were available from an e-Bay seller for less than \$9 per 100.

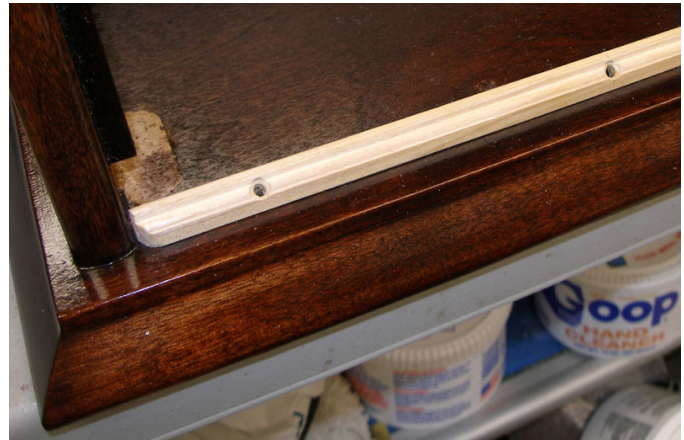
13. There is a thin mahogany strip along the front-bottom of the cabinet that is missin:. I fabricated a reproduction using furniture grade poplar. Fortunately I found great photos of the set in a e-Bay listing. The scale of the part is such that the difference in the kind of wood makes little difference, all that matters is getting the red mahogany coloration close enough to correct. I was not in a position to fabricate the exact profile without ordering a special router bit, however it seems to look close enough so as not to not attract attention to it being wrong.

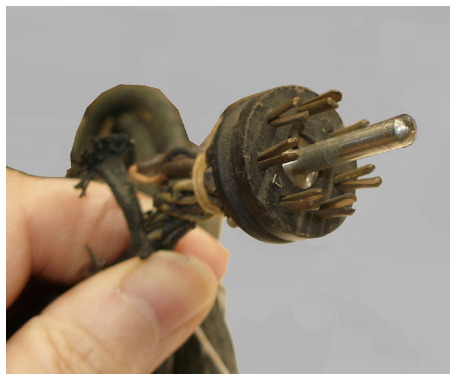
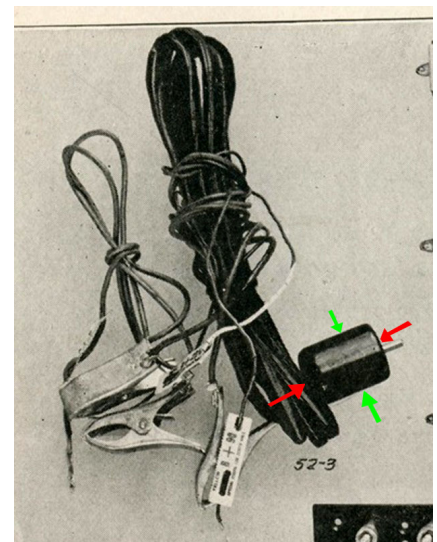
Photo from Zenith Parts List

14. There is no mating Jones plug for the battery connection socket. A reproduction plug was fabricated. These mating plugs are scarce. Maybe a clue to their scarcity is the fact that, at least in the case of Zenith, the battery connection cable was made with plain rubber covered wires. I suspect that many people over the years would

have found a cable full of crumbling rubber wire as something to toss in the trash. I have one of these cables missing the Bakelite shell for the plug. But at least it gives me dimensions for the plug components. A correspondent on Antique Radio Forum provided me with a photo of the shell and there is a Zenith parts manual that shows the complete cable. I have made 8 of these replica plugs.

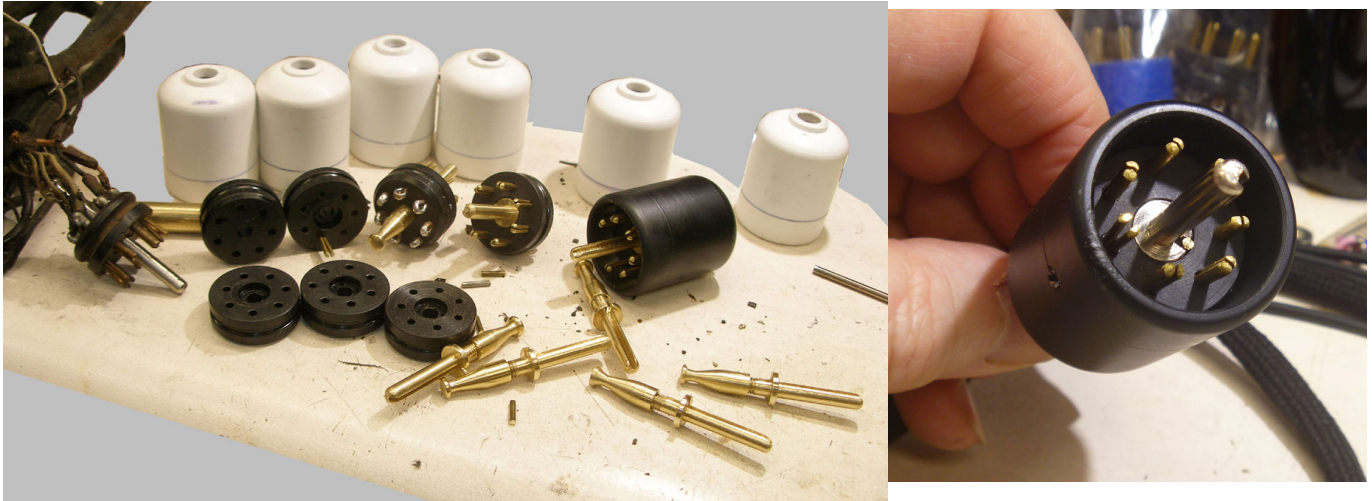
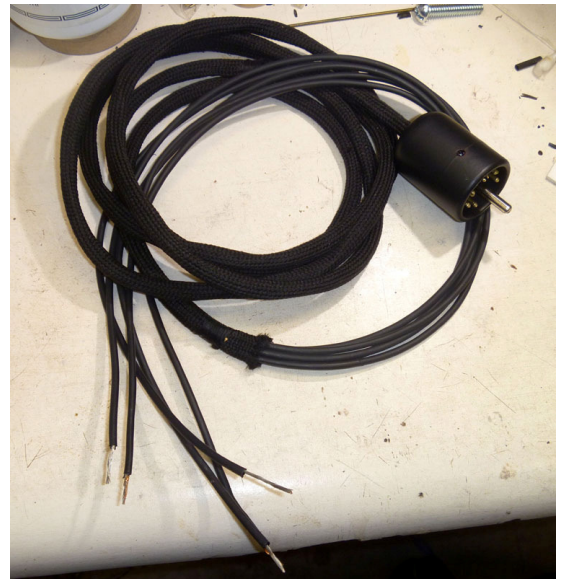
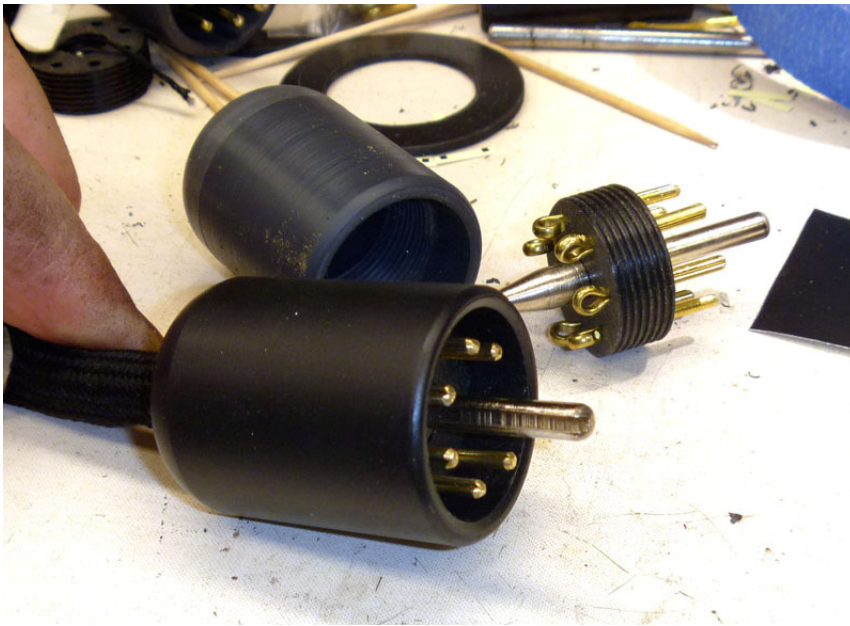
The one detail that has not yet been resolved is how the button in my vintage plug assembly (the part that holds the 7 pins) was retained in the outer shell. As mentioned, the outer shell is missing on my old cable. Note that the old button has a 1/8" groove around the button. Was a spring steel ring forced into the groove and snaps into a groove cut in the inside wall of the shell? That is about the only thing I can figure. That could complicate disassembly; I eventually decided to scrap my first shells shown above to make new shells that are tapped 1"x 20 UNEF machine thread. This is like a plug photographed by an ARF Forum member. Maybe Jones decided that a spring ring scheme did not work well. It could also be that, initially, they were trying to avoid the expense of threading the parts.

Rubber insulated wire is not available. Modern insulations do not resemble the dull rubber luster. What to do? My best solution to date is to strip the insulation from 18 or 16 gauge stranded wire and replace it with polyolefin shrink tubing. Certain brands of the thin versions of

this tubing come very close to the look of rubber. The only downside is that two layers are required to build the insulation diameter up to the correct size. This is a tedious process.

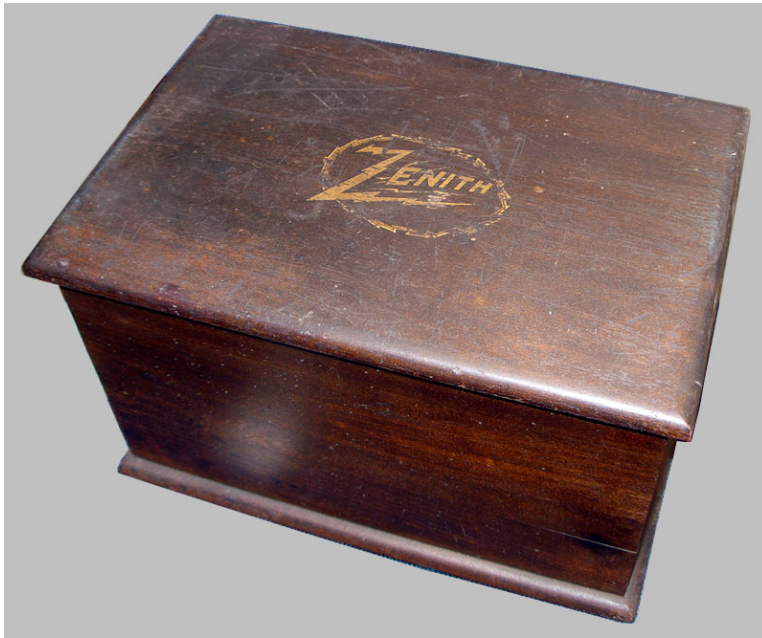
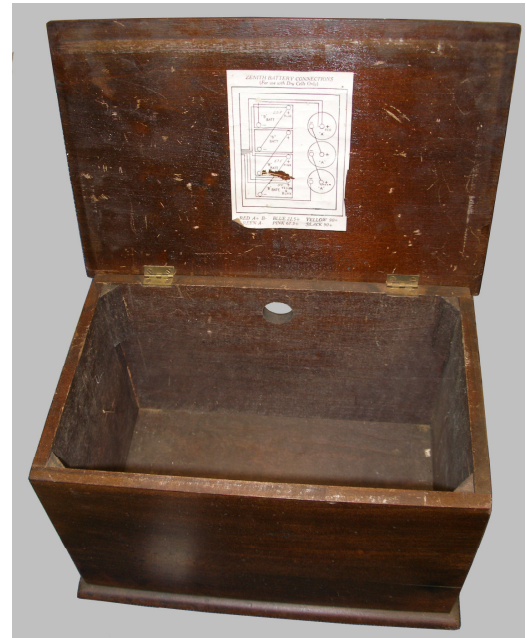
15. This battery cable connects to an assortment of batteries and many years ago I found a Zenith dry cell battery box as shown here in this exhibit. There is no doubt it is authentic. There is a reason I have not refinished the box to match the pretty looking cabinet of my 3R. To date, no collector I know of has ever seen an example of this battery box. If it is the only surviving example, extra ordinary care must be taken to preserve the artifact details. In this case, at least for now, I have only provided a minimal amount of cleaning.

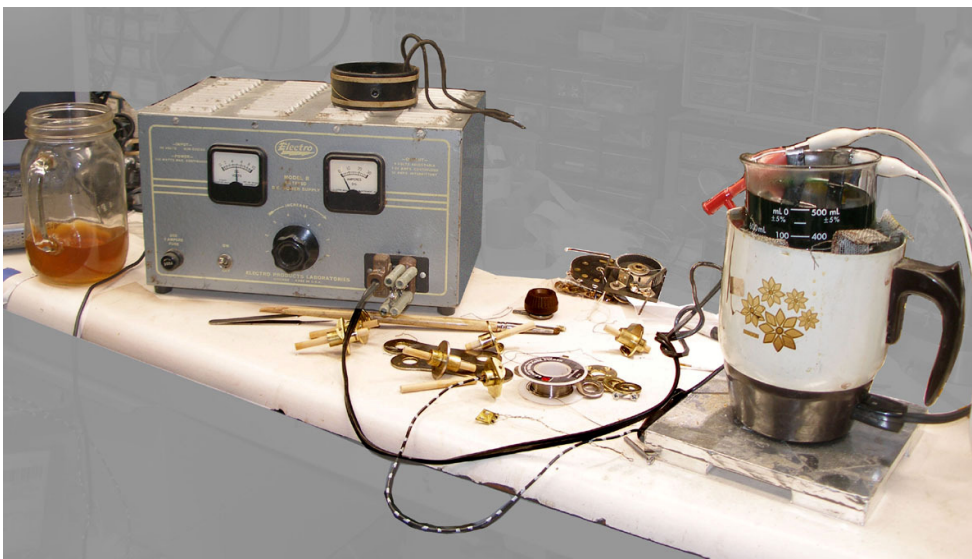
16. The steel bracket of the feedback coil was corroded and I cleaned and re-plated the part. In order to rivet the part back in place, I had to machine down two of the semi-tubular rivets to the proper length and then fabricate a custom punch and die to set the rivets.

17. All metal parts were run through the ultrasonic cleaner.
