Radiola M 55
SVENSKA RADIOAKTIEBOLAGET
Stockholm, Sweden
Circa 1927 - 1929

How I acquired and restored this M 55

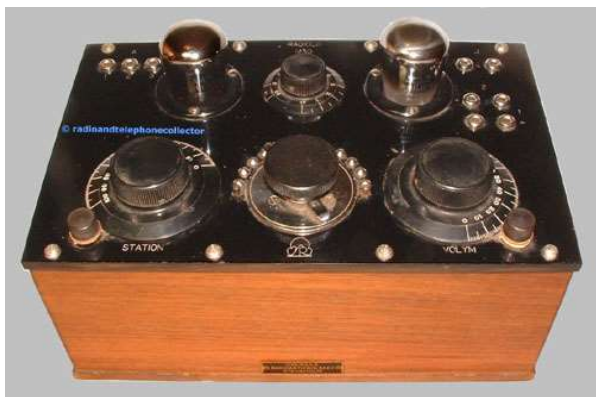
← Predecessor valve sets such as this Model M 30 offered very tidy layouts but quite utilitarian in their cabinet design.

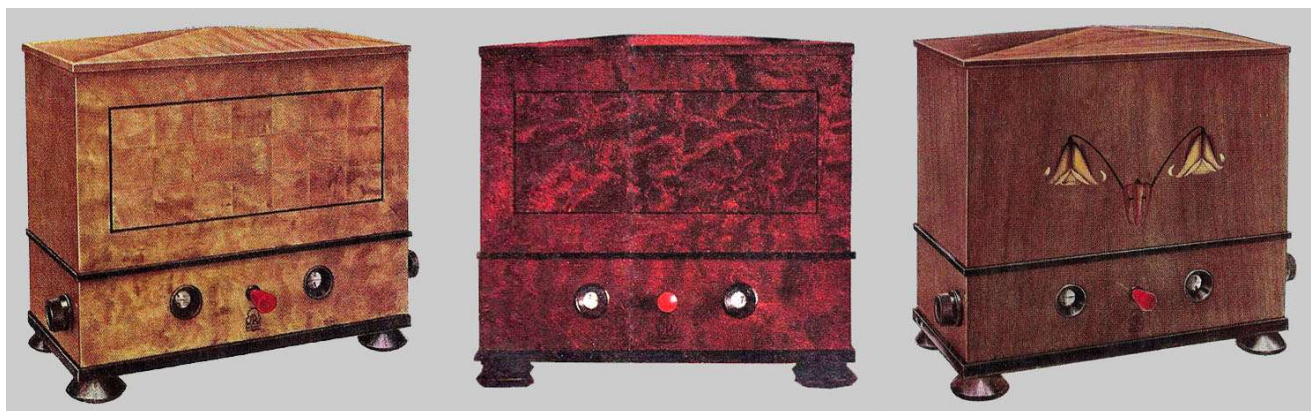
↓ However, this three valve Model M 55 receiver presents a radical departure from that lineage, offering an elegant compact cabinet of distinctively Nordic design sensibilities, with no apparent equivalent design from any other manufacturer.

There were three variations of this cabinet. One with this checkerboard marquetry scheme in Baltic Birch, a version finished in Mahogany veneer with a highly figured Mahogany front panel inlay and Walnut veneer version with marquetry inlay motif of two Bell Flowers. This radio was described as the “housewife’s radio” because it was said to fit nicely into any home décor.

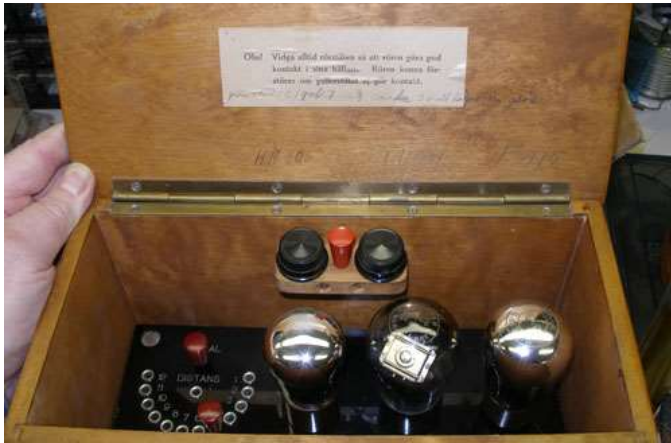
Note that the center version of the cabinet pictured on the previous page does not show the tuning and volume control knobs on the sides of the cabinet. This is in keeping with the 'housewife radio' simplicity concept. 'Dad' could tune the radio to the desired station and store the knobs on this little shelf along with the shorting

plug used to turn the radio ON; thus insuring that the radio did not get out of adjustment!

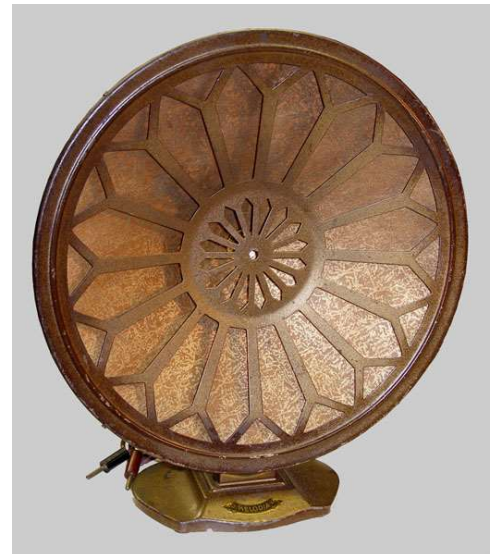
I do not have a horn or cone speaker of Swedish manufacture in my collection. The Swedish market of the day had a significant percentage of import radios and accessories from Germany and England in particular. The German made GRAWOR "*Melodia*" cone speaker on display here was definitely popular and available for sale in Sweden circa 1927.

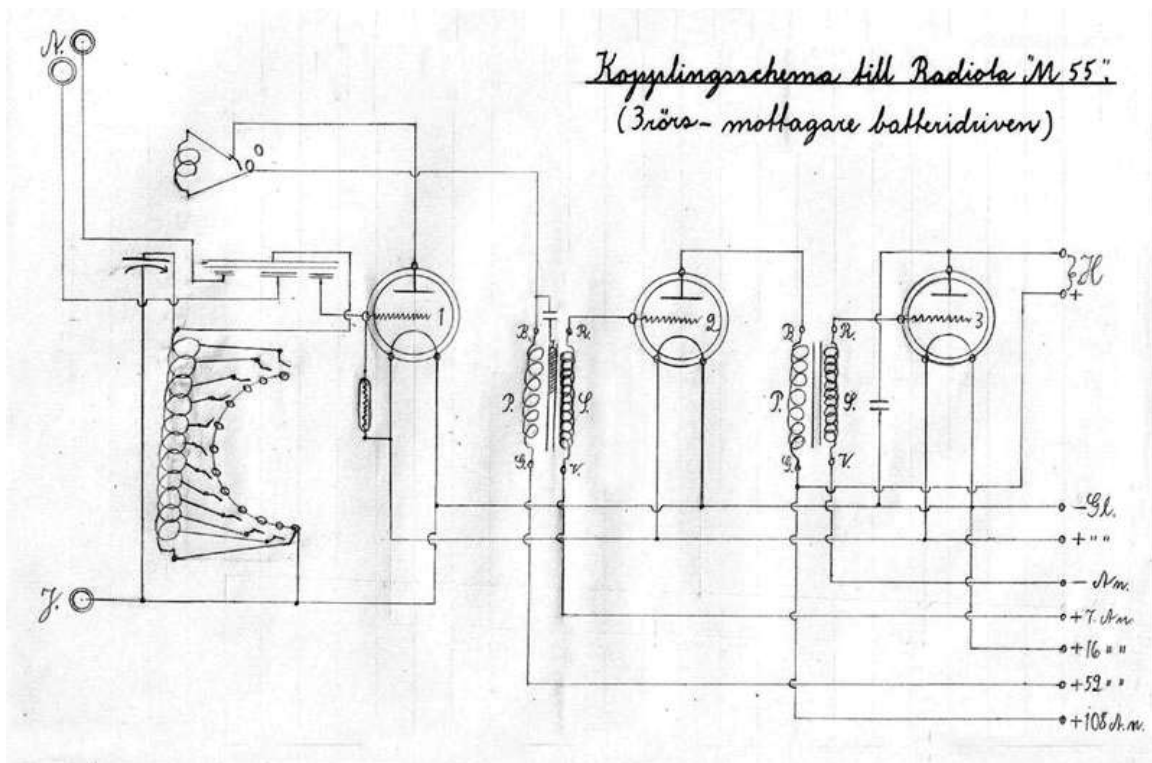
This receiver features a regenerative detector with a single parallel tuned circuit coupled to the antenna by your choice of two small value capacitors of a most unusual construction. The parallel tuning condenser is a maximum 220 pF. and the tuning coil has 11 taps. A shorting plug is inserted in one of the 11 tap holes to establish a basic tuning range; the bottom end of the coil thus being shorted out. The tuning range is from 140 to 2100 M. The regeneration coil rotates in the usual fashion at the top end of the tuning coil. For local stations, the minimum amount of feedback provided by this coil may not be low enough to prevent oscillation. The solution was to provide for another shorting plug that could be inserted across the leads of the feedback coil to kill the signal altogether for local reception.

Back to the unusual antenna coupling capacitor... It is a length of brass tubing wrapped with a sheet of mica. On top of the mica, three windings of about 26 AWG wire are wound. Just one end of each winding is brought out from each coil. Thus they are using this winding not as a current carrying inductance but simply as one plate of a capacitor, the other plate being the brass tube! The third winding (capacitor plate) provides capacitive coupling from the tuned circuit to the grid of the detector tube.

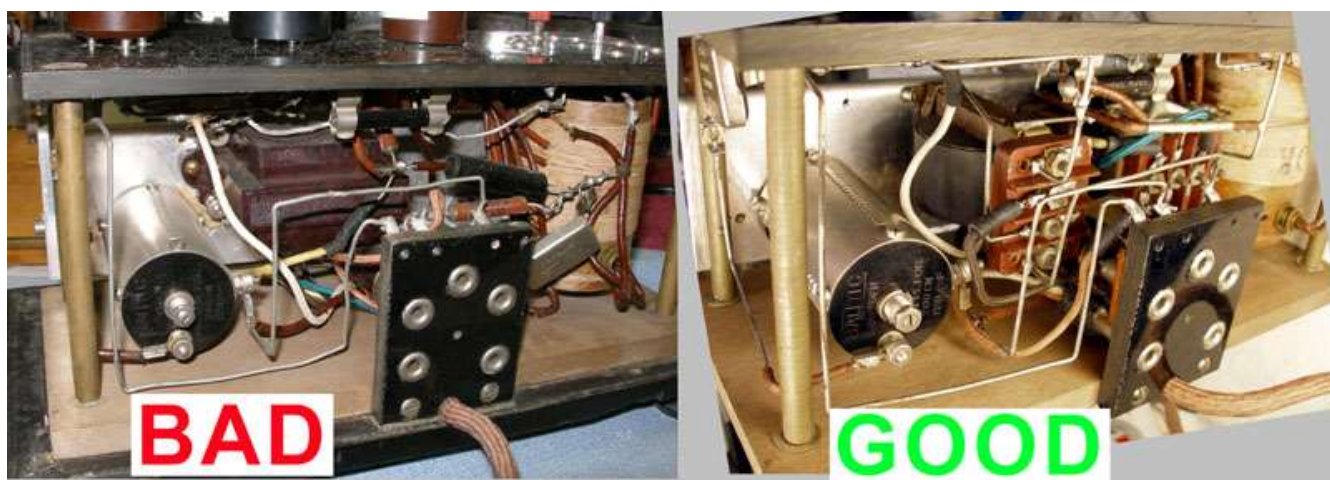
In his hotel room we unpack the radio and I am delighted to find that the missing wood strip was inside the cabinet. We proceeded to remove the cabinet to examine the chassis and my heart sank. I had seen a few low resolution photos on *radiomuseum.org* of the chassis and could see immediately that the original audio transformers were missing and someone had very crudely installed one audio transformer and a R-C audio coupling circuit to replace the second audio. (The replacement audio did not leave enough room to mount a second audio.) The original spring mounted *Detector* socket was missing and a substitute rigid mount socket filled the hole.

It appeared to me that these repairs had been made in recent times and may have been done primarily so that it could be sold at a premium

Still I was not at all disappointed that Bengt had acquired the radio for me. NOW the quest was on to obtain the correct parts. Unfortunately the transformers rarely turn up and I needed TWO of them.

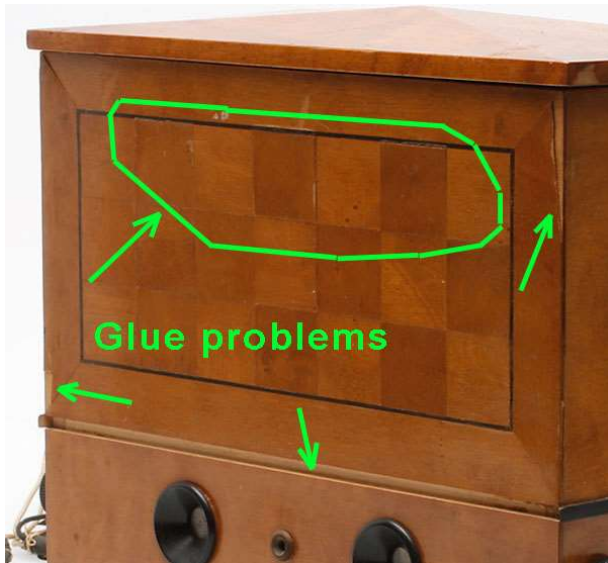
While waiting to solve the parts problems, I reserved time for repairing the cabinet. Baltic birch plywood is commonly available and I had some in my shop. I shaved down a little piece to the required thickness and proceeded to replace the missing veneer. Of course it always takes a long time to get an acceptable color match and it is not perfect but the repairs are not so bad as to attract special attention to the casual viewer.

The little squares of loose marquetry were a challenge because 6 or 7 of the squares were loose and curled on only one or two edges. The other 14 or 15 squares were still tightly bonded. I decided to carefully coat the front of the cabinet with a thin coat of paste wax being careful to avoid getting the wax on the edges of the loose marquetry. The application of wax makes it possible to peel off the excess glue that will be expelled from

I used a 1/4" wide strip of phosphor-bronze shim stock 0.008" thick as a probe to slip under the loose pieces and tease-out any granules of the old hide glue or wood fragments while providing a mild jet of compressed air to help clear the material.

I selected *Titebond Extend Wood Glue* for this task because of its slow set characteristic. Ordinarily I would put the glue in a syringe bottle and inject it under the veneer. Here, much of the veneer did not want to flex enough to get the needle in place, so I used the strip of shim stock to push the glue under as far as possible. The slow set characteristic of the glue gave me plenty of time to work. After gluing a couple of squares, I placed a sheet of *Mylar* film over the wood, topped with a 1/8" thick sheet of soft *Neoprene* rubber and finally a 3/4" thick rectangle of MDF shelving AND another piece of the MDF for protection of the back side of the panel. The sandwich being clamped together with heavy duty beam clamps for an overnight drying time.

After three sessions of gluing, all that was necessary is to freshen-up the French polished shellac finish after having washed-down the cabinet with mineral spirits to remove the protective wax.

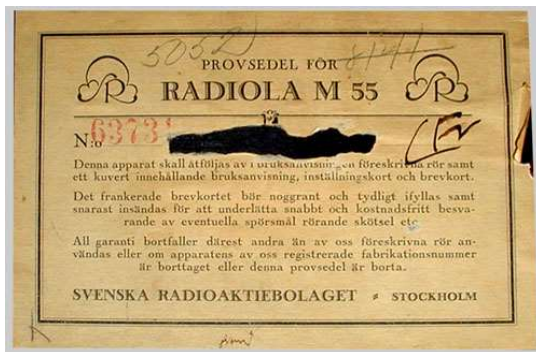
1. I find it odd that the paper label on the bottom of the cabinet has been purposely defaced. The inspection date has not just been

marked out, but the paper where the date was written has been torn out! There are cryptic numbers marked in pencil. Bengt, reports a #63209 dated 23-Dec-1927 and #64300 dated 1-Feb-1928. So my #63731 must have been made January, 1928.

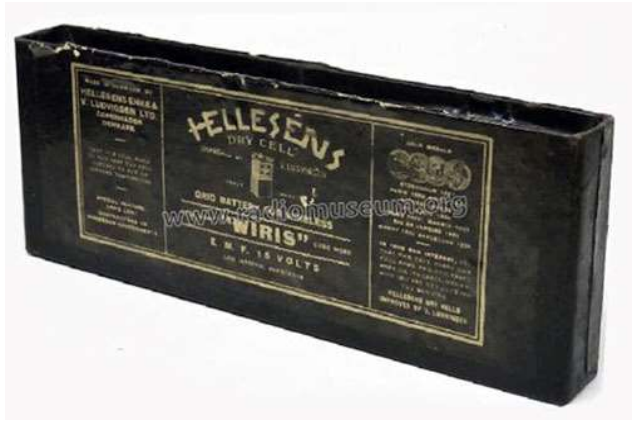
15 volt battery #WIRIS made in Denmark.

Bengt Svensson thinks that grid bias batteries were not made in Sweden during the 1920s. I presume this is the case probably because sales volume for this battery, that might not need to be replaced but once every three years, did not justify the tooling for domestic production.

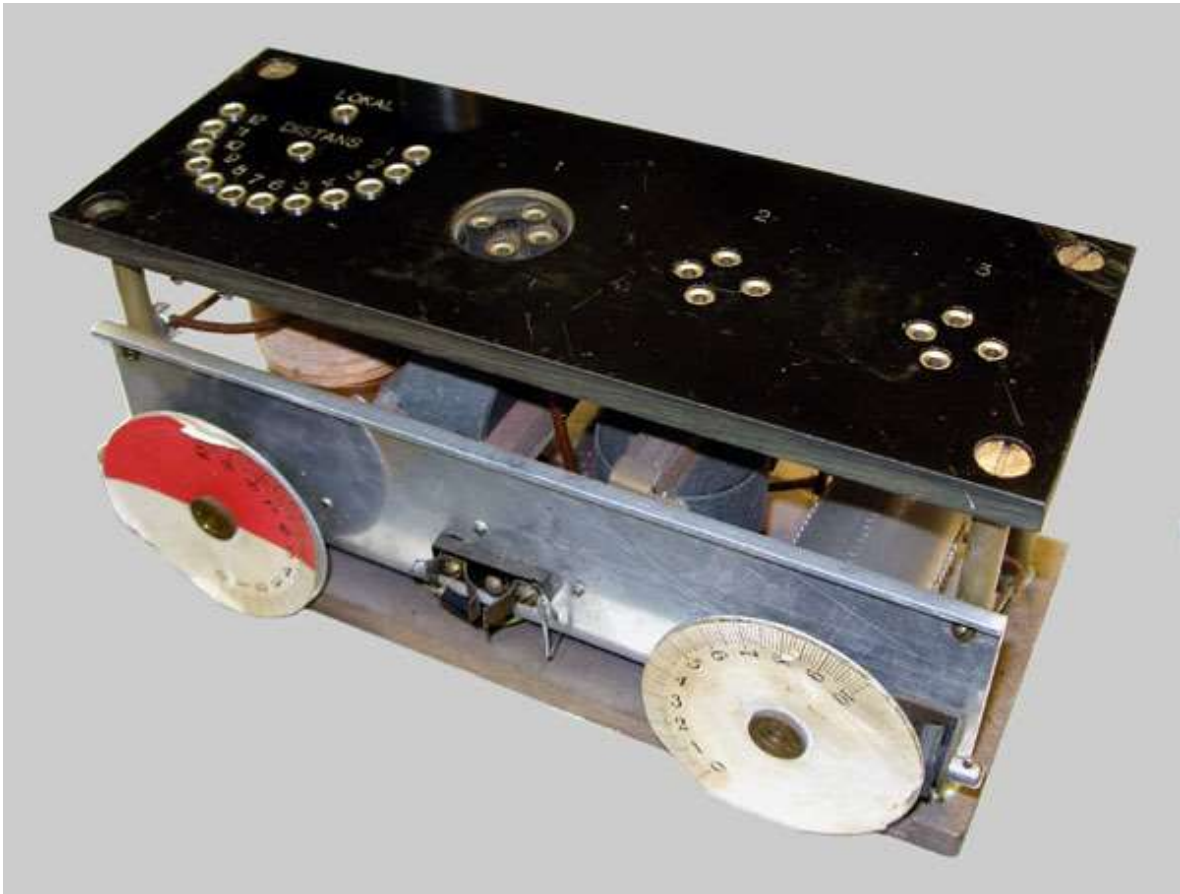
Front view of M 55 chassis. Note that the Detector socket floats on leaf springs (a very common method of reducing microphonic feedback caused by vibration of the vacuum tube elements). Little rubber tires

convey friction drive to the back sides of the tuning and volume control dials. The radio is turned ON by inserting a shorting pin between the leaf contacts mounted between the two dials. This completes the tube filament circuit.

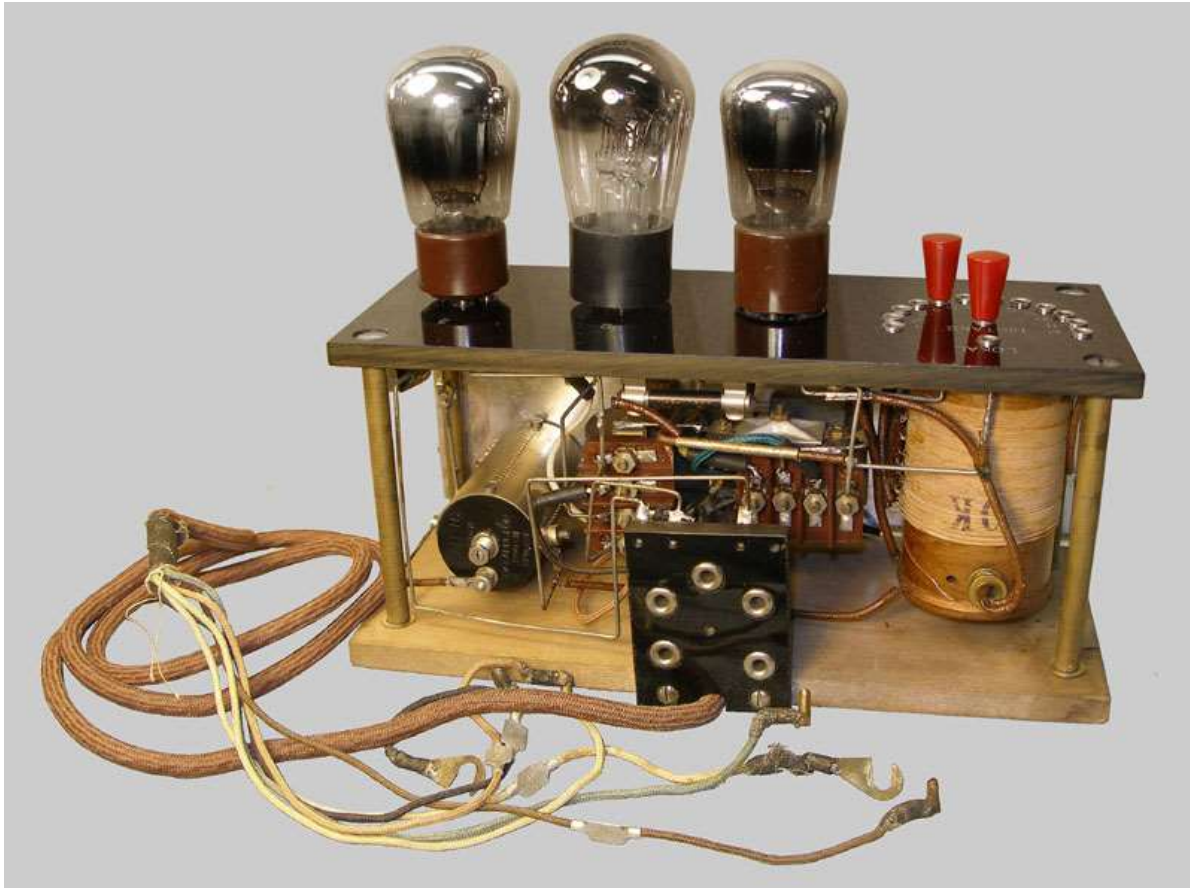
The majority of these radios would have been fitted with 2 Volt filament tubes. The filament current consumption was low enough to be supplied from dry batteries although 2 Volt lead acid storage batteries were fairly common in usage. SRA offered Radiola branded tubes most likely supplied by Philips. The type Radiola II for Detector and 1st. Audio and the type Radiola 1II for the audio output. I currently have two Philips tubes and one made by Tungstram that are supposed to be reasonable substitutes available in the late 1920s.

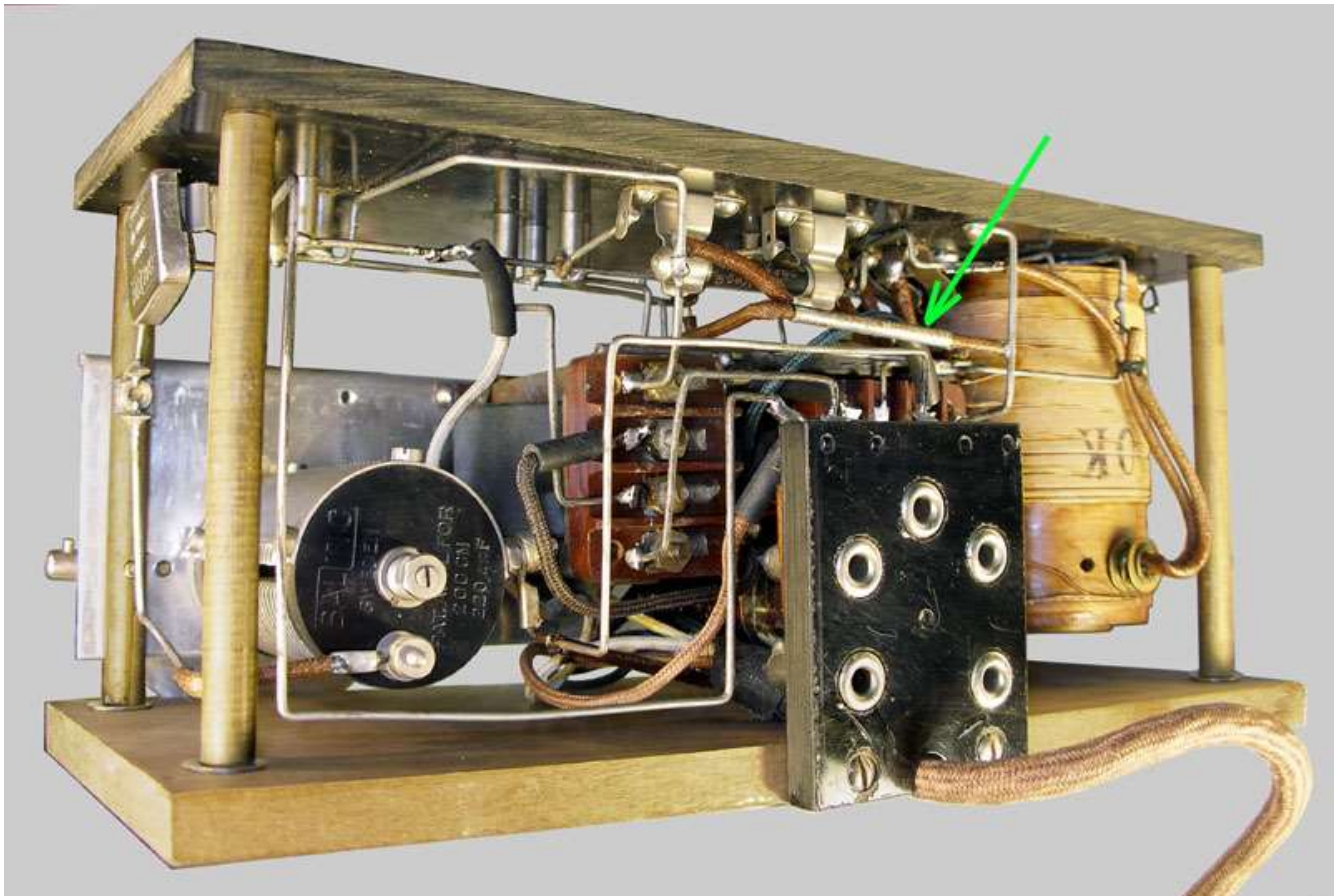
Green arrow points to 'gimic' capacitor wound over insulated buss wire connection to the grid of the first audio amplifier tube.

Note rubber sleeves on ends of battery cable wires to prevent fraying of the braided thread insulation.

There is an interesting 'gimic' capacitor wound over the insulated grid wire connection for the first audio amplifier. The gimic wire is connected to the grid of the second audio amplifier. This device is present in both

chassis I have examined but not shown on the schematic. I suspect that the phasing of the connection is such as to suppress high frequency ringing.

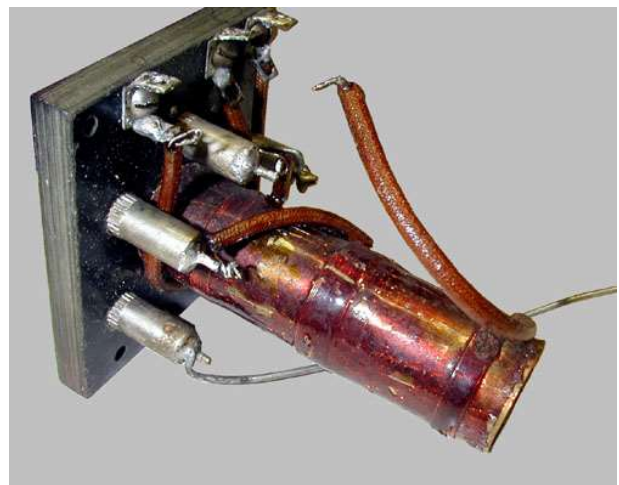
Unusual 3 section capacitor using copper windings for plates.
